# Service Bulletin

Bulletin No.: PIT5204

**Subject:** Various Electrical Concerns And / Or Blown Fuse

**Models:** 2013 Buick Enclave  
2013 Chevrolet Traverse  
2013 GMC Acadia

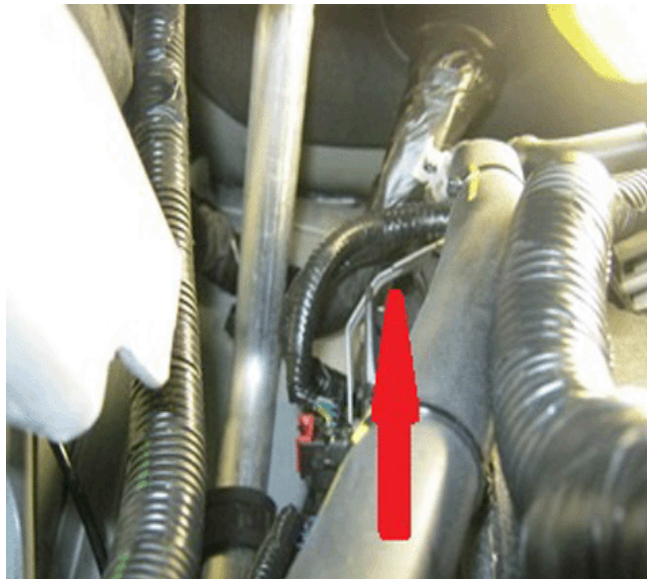
3302505

This condition may be caused by the engine wiring harness damaged at the right rear side of the engine compartment. The harness may have chafing or damage to the wires at the power steering bracket or line.

If the SI diagnostics do not isolate a cause for this concern, inspect the wiring harness for a potential short to ground, at the right rear side of the engine compartment about 6 inches from the pass-through where the harness may contact the steering line or the steering line bracket:

Repair any chafed or damaged wires by following SI repair procedures.

Further, re-route the engine harness by following the procedure below:

1. Remove the nut for the A/C Line retainer found on the front of dash located above where this harness pass through is located.
2. Remove the nut for the retainer of this same A/C line, but this retainer is located on the frame rail on the RH side of the engine compartment.
3. Move the A/C line enough to access the harness retainer nut located on the RH frame rail.
4. HOW DO I MAKE A 4.1/4.2?
5. Pull the harness where it is routed up along the strut tower toward the engine. This will rotate the harness on the weld stud and provide clearance between the harness and the PS cooler pipe.
6. While pulling on the harness, tighten the harness nut to hold the harness in that orientation.
7. Reinstall the A/C line retaining nuts and check the harness for sufficient clearance to the PS pipes.
