Service Bulletin

Bulletin No.: PIT5203A

Subject: SES Indicator Or Open HVAC Fuse

Models: 2013 Chevrolet Equinox
Built at Spring Hill Assembly (Plant Code / 11th Digit of VIN = "Z")
Equipped with 2.4L Engine (RPO LEA)

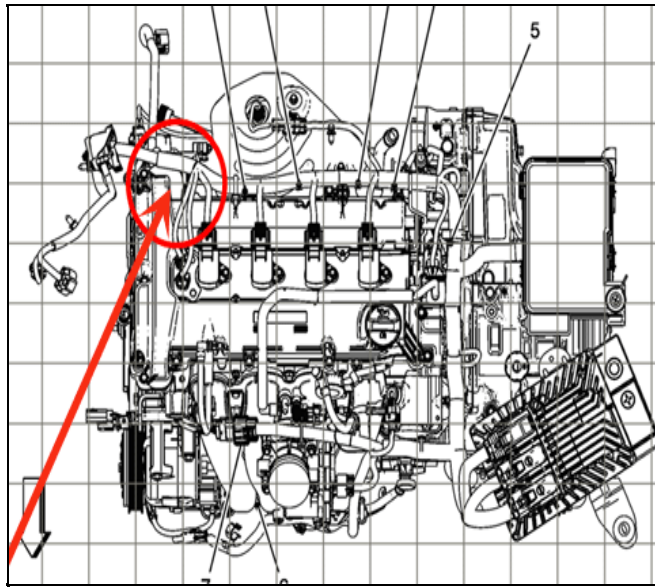
3341025

These conditions may be caused by the main engine wire harness making contact with the right rear corner of the engine or cam/valve cover.

Repair the affected circuit, wrap the harness with additional protective tape and route the harness away from suspect areas of engine component contact.
