Service Bulletin

Bulletin No.: PIT5199A

Subject: Whistle Wind Noise From Drivers Side Mirror Area

Models: 2012 - 2013 Chevrolet Equinox
2012 - 2013 GMC Terrain

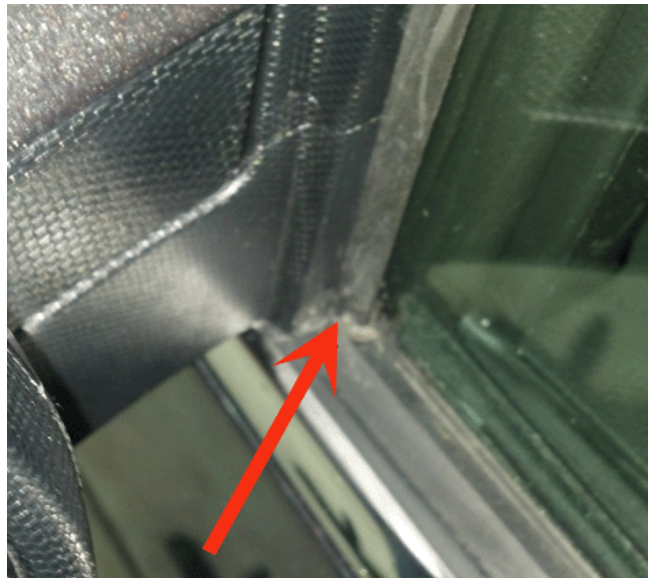
3277930

Customer may comment on a high pitched whistle or wind noise from the driver's side mirror area between speeds 25 to 52 mph. This may be caused by a gap between the belt molding and the bottom of mirror mounting patch. This may be caused by a void in the sealing area in the corner of the belt molding and the door glass frame at the front toward the A pillar. See picture below.

Suggest using a rubber mallet and lightly tapping on the belt molding - moving it toward the A pillar area. This will close the gap slightly (measure the gap between the end of the belt molding and the window a-pillar). Next, remove the belt molding, use a suitable piece of rubber (weather strip or suitable material), and glue it to the back side of the of the belt molding to extend it to fill the gap. Reinstall the belt molding. This will fill the remaining void in the seal. Use a piece of tape to keep it in place until the glue dries.
