Service Bulletin

Bulletin No.: PIT5199

Subject: Whistle Wind Noise From Drivers Side Mirror Area

Models: 2012 - 2013 Chevrolet Equinox
2012 - 2013 GMC Terrain

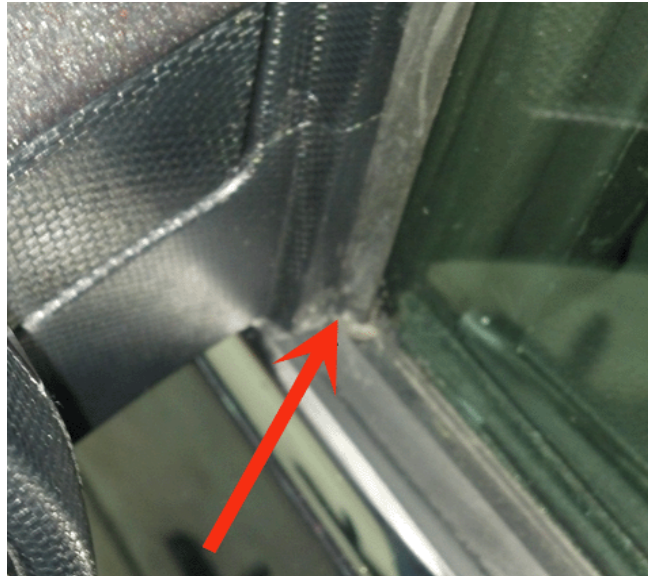
3277930

Customer may comment on a high pitched whistle or wind noise from the driver's side mirror area between speeds 25 to 52 mph. This may be caused by a gap between the belt molding and the bottom of mirror mounting patch. This may be caused by a void in the sealing area in the corner of the belt molding and the door glass frame at the front toward the A pillar. See picture below.

Suggest using a rubber mallet and lightly tapping on the belt molding moving it toward the A pillar area. This will close the gap slightly. Use a suitable piece of rubber and glue it to the rubber seal portion of the belt molding. This will fill the remaining void in the seal. Use a piece of tape to keep it in place until the glue dries.
