# Service Bulletin

Bulletin No.: PIP5156

**Subject:** Possible Oil Leak On Gen 5 Engine After The Harmonic Balancer Is Removed Or Replaced

**Models:** 2014 Chevrolet Corvette  
2014 Chevrolet Silverado 1500  
2014 GMC Sierra 1500  
Built with RPOs 4.3L 5.3L 6.2L L83 L86 LT1 LV3

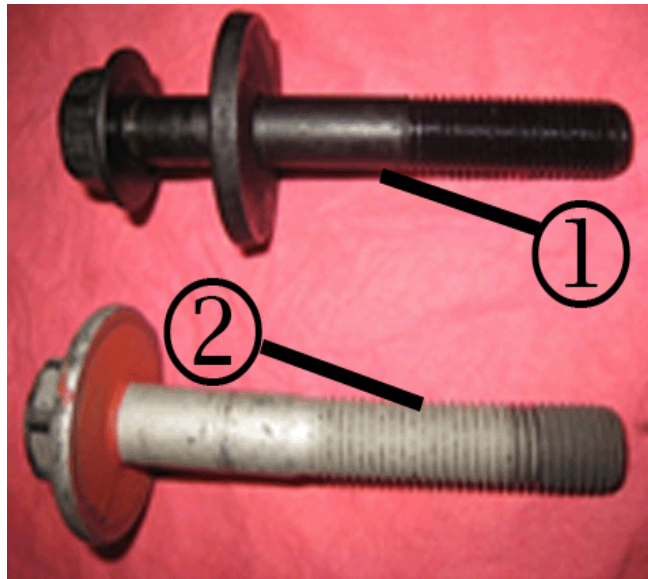
**Note:** If you use a Gen 4 bolt in a Gen5 engine you will have an oil leak.

1- is for a gen 5 engine

2- is for a gen 4 engine
