Service Bulletin

Bulletin No.: PIP5149A

Subject: P0324 Setting And/Or Poor Shifting Transmission During The 1-2 And 2-3 Shifts

Models: 2014 Chevrolet Silverado 1500
2014 GMC Sierra 1500
Built with RPOs 4.3L 5.3L L83 LV3

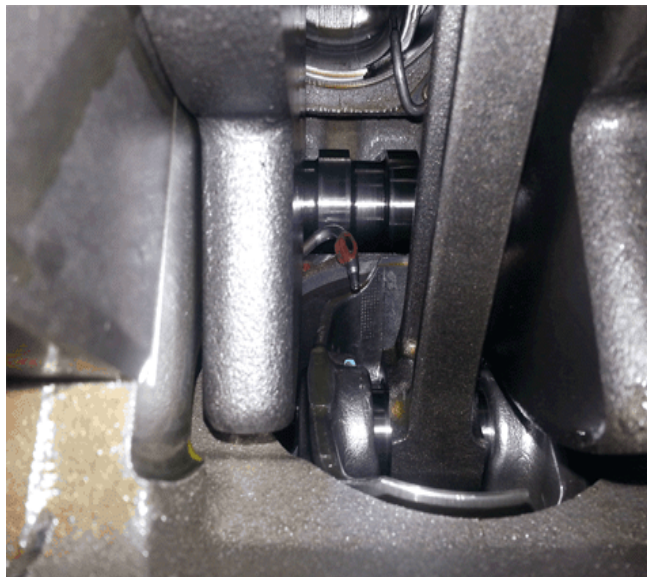
3608974

A connecting rod may be contacting one of the piston squirters causing a noise that is detectable by the knock sensors.

The dealer is authorized to remove the oil pan and inspect the oil squirters for contact.

If contact is noted the dealer needs to call PQC for a replacement engine. (PER PIP5114)
Pictures of normal crankshaft marking that are not caused by the oil squirter making contact.
