Service Bulletin

Bulletin No.: PIP5149

Subject: P0324 Setting And/Or Poor Shifting Transmission During The 1-2 And 2-3 Shifts

Models: 2014 Chevrolet Silverado 1500
2014 GMC Sierra 1500
Built with RPO's 4.3L 5.3L L83 LV3

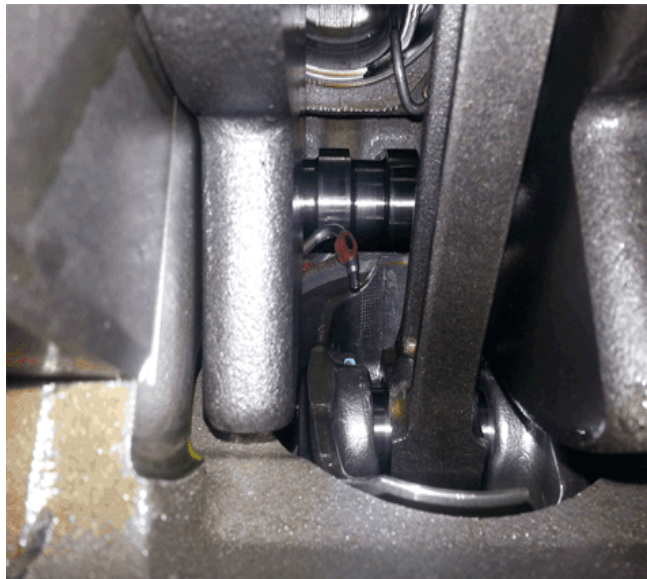
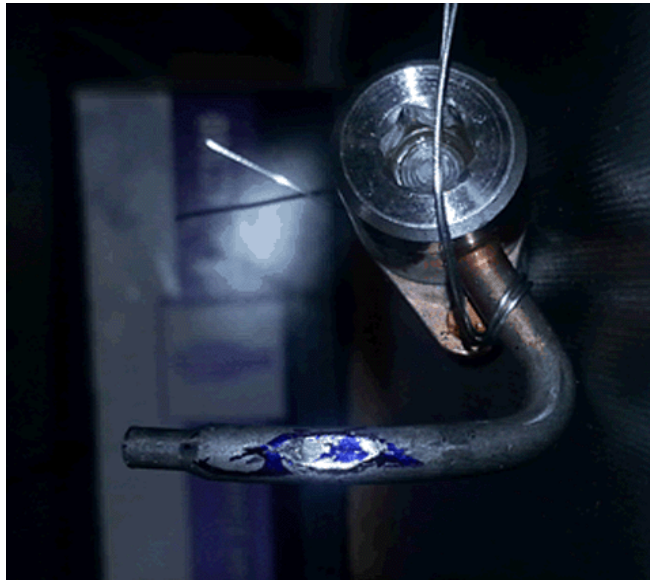
3608974

This concern of timing retard may be caused by the connecting rod contacting one of the piston squirters causing a noise that is detectable by the knock sensors.

The spark retard may be an indication the ECM is compensating for the connecting rod(s) contacting one or more of the piston squirter(s).

The dealer is authorized to remove the oil pan and inspect the oil squirters for contact.

If contact is noted the dealer needs to call PQC for a replacement engine. (PER PIP5114)
