# Service Bulletin

Bulletin No.: PIP5147A

**Subject:** SES Lamp P0300 P0351 - P0358

**Models:** 2014 Chevrolet Silverado 1500  
2014 GMC Sierra 1500  
Built with RPOs 4.3L 5.3L L83 LV3

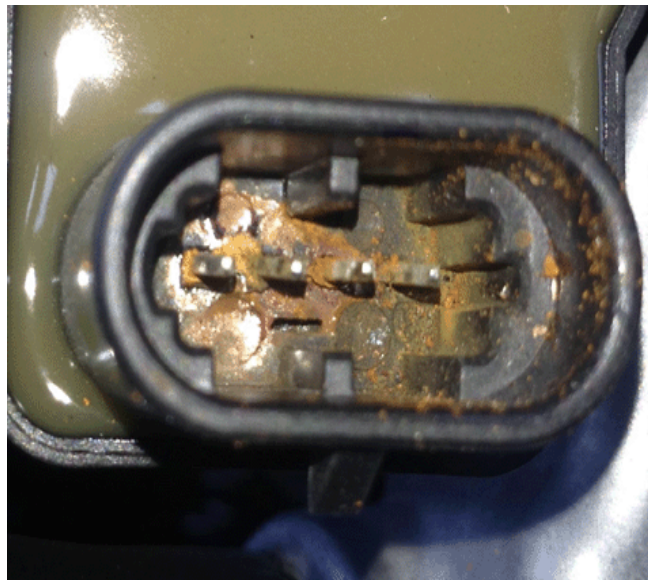
3620542

Inspect the coil connectors for a clear water and/or a discolored connector.

Picture of a coil with the concern:

If this is found inspect the pigtail for pin drag or loose terminals (repair as needed).

Swap the coil to a known good location.

If the concern follows the coil replace the coil or coils with the concern and add dielectric grease to the connection.
