Service Bulletin

Bulletin No.: PIP5123A

Subject: SES Lamp On With DTC P2270

Models: 2013 Chevrolet Silverado
2013 GMC Sierra
Built with 4.8L 5.3L 6.0L RPO L20 LC9 LMG L96

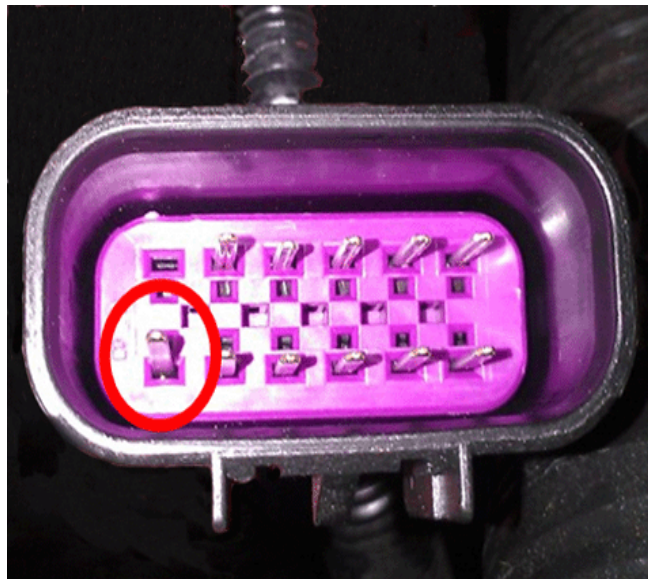
3454867

Concern of DTC P2270 setting along with any of the following codes P0140, P0139, P0138, P0137, P013A, P013B on vehicles built at the Fort Wayne assembly plant during February 2013.

Check connector X131 for a bent terminal F as indicated in the attached PIC and repair per SI procedures.

If no connector issue is found, follow SI diagnostics.
