Service Bulletin

Bulletin No.: PIP5122A

Subject: Pop Noise From Fuel Tank After a Cold Start or EVAP Purge Event (Equinox / Terrain)

Models: 2010 -2014 Chevrolet Equinox
2010-2014 GMC Terrain

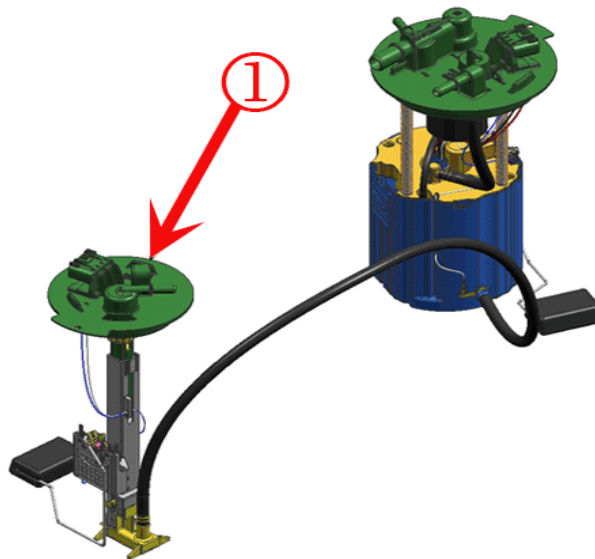
(1) Flange location

The part number on the box of the auxiliary fuel module has not changed but the auxiliary fuel module inside of the box has. After ordering the auxiliary fuel module, remove it from the box and verify the letters "PPA" are casted into the top of the fuel module flange. This is the revised auxiliary fuel module designed to correct the pop/popping noise. The original auxiliary fuel module has "POM" casted into the flange.
