# Service Bulletin

Bulletin No.: PIP5122

**Subject:** Pop Noise From Fuel Tank After a Cold Start Or EVAP Purge Event (Equinox / Terrain)

**Models:** 2010 -2014 Chevrolet Equinox  
2010-2014 GMC Terrain

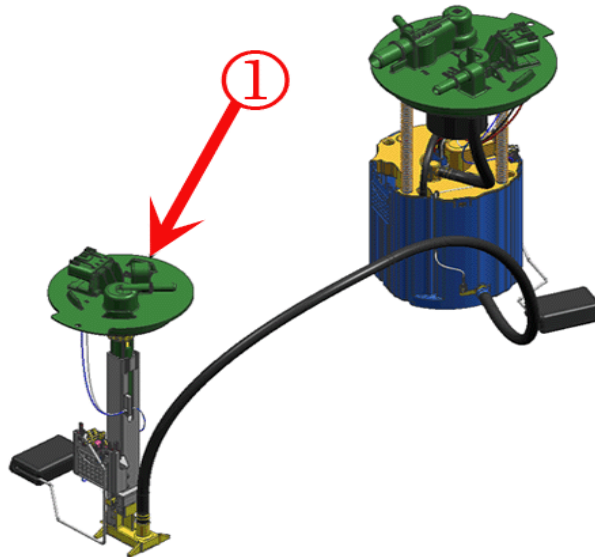
3460471

The technician should be able to duplicate the concern by commanding a purge and seal on the EVAP system using GDS2. As the vacuum reaches 3 to 5 inches, the pop/popping noise should be duplicated. The cause for this concern is the auxiliary fuel module in the left side of the fuel tank changing height (spring loaded leg) as the fuel tank collapses slightly.

(1) Flange location

The part number on the box of the auxiliary fuel module has not changed but the auxiliary fuel module inside of the box has. After ordering the auxiliary fuel module, remove it from the box and verify the flange (indicated in the picture below by "1") of the auxiliary fuel module where the spring loaded "leg" fits into, is either light green or light orange in color. This is the revised auxiliary fuel module designed to correct the pop/popping noise. The original auxiliary fuel module has a flange that is white in color.
