Service Bulletin

Bulletin No.: PIP5115

Subject: SES Lamp P0011 Setting After Camshaft Replacement

Models: 2010-2014 Cadillac Escalade
2010-2014 Chevrolet Camaro
2010-2014 GMC Yukon Denali
With engine RPO 6.2L L94 L99

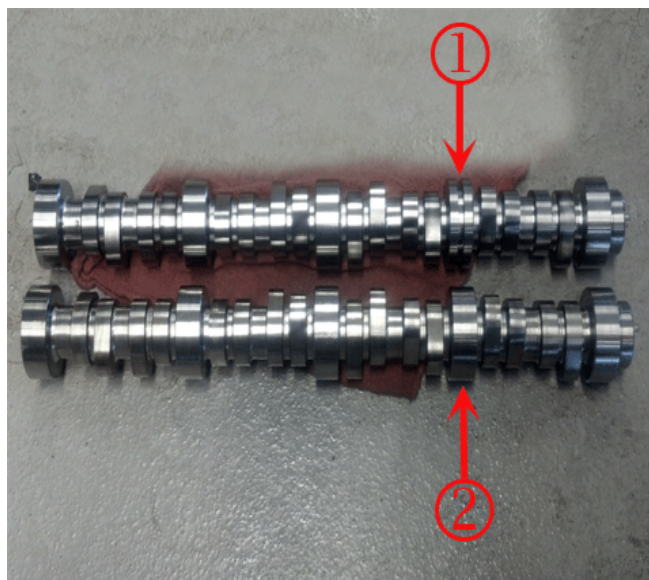
You may encounter a P0011 setting after the replacement of the camshaft.

1. Shows a good camshaft
2. Shows the wrong camshaft

Inspect the camshaft to determine if the correct Part number has been installed. The inspection consists of verifying the last 4 digits on the camshaft (stamped on the end) match the part number listed on the box.
