Service Bulletin

Bulletin No.: PIP5105

Subject: Diagnostic Tip - Damaged Ignition Coil Assemblies Due To Improper Service Procedures (Special Tool Required)

Models: 2013 Buick Encore
2009-2011 Chevrolet Aveo
2011-2013 Chevrolet Cruze
2012-2013 Chevrolet Sonic
2013 Chevrolet Trax
Equipped with 1.4L / LUJ / LUV 1.6L / 2H0 / LXV 1.8L / LUW / LWE

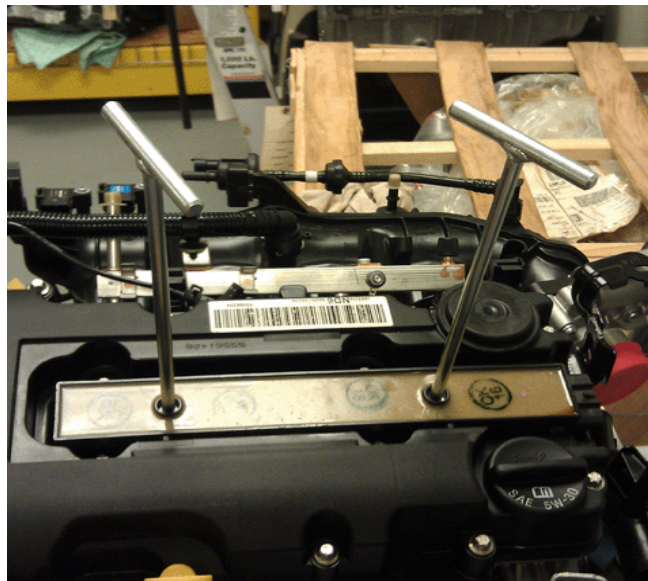
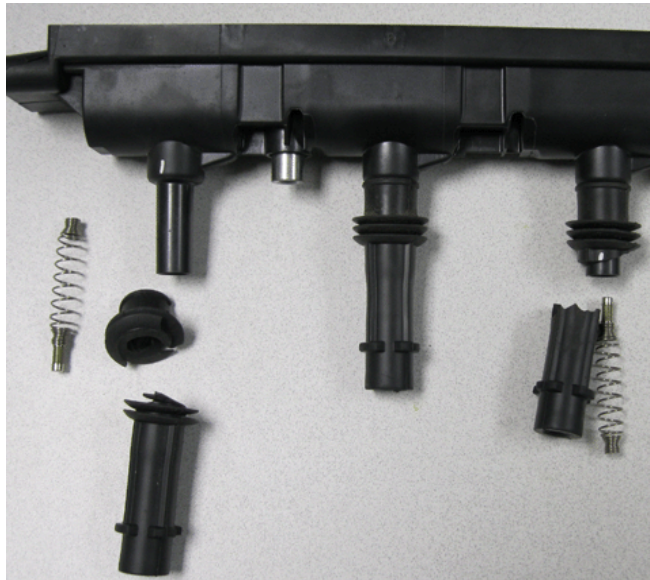
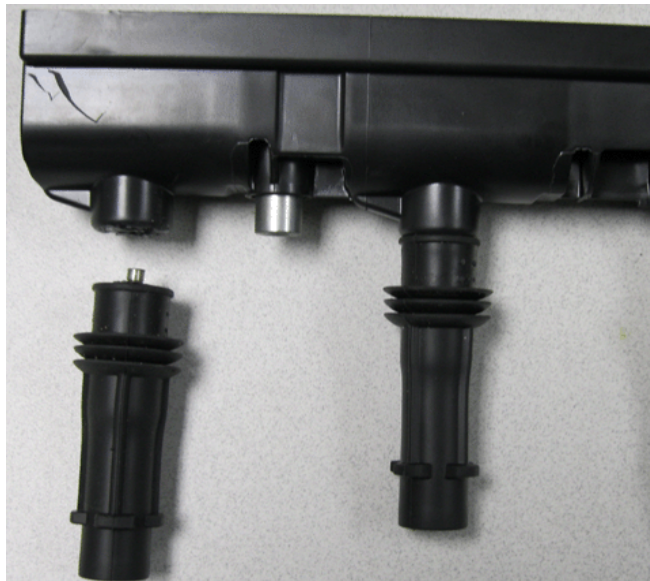
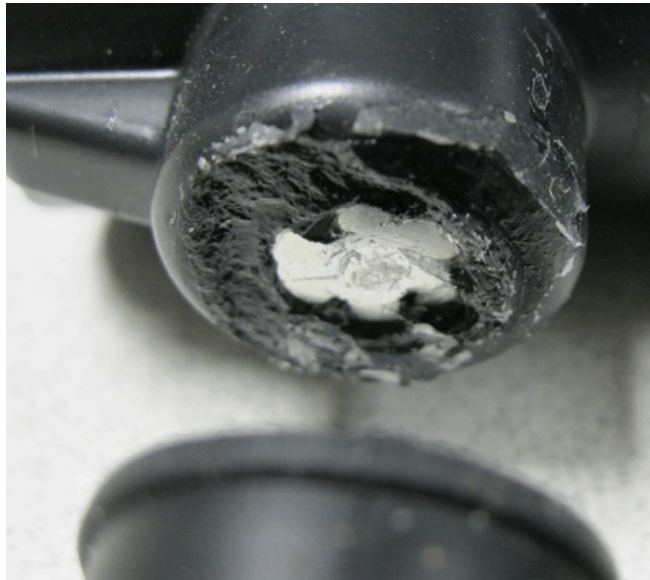
A technician may find broken or damaged ignition coil high tension towers or boots after coil assembly removal. (See Pictures below)

This type of damage is caused by prying up on one end of the coil assembly.
The EN-6009 tools must be used to lift up at equal angles at both ends of the coil assembly.

Coil removal on these engines requires the use of special tool EN-6009 (Remover and Installer Ignition Module).
The latest design of this tool is shown in the picture. (Tee handle type).
Earlier versions of the EN-6009 may not be of the same design.
Please utilize this tool as listed in SI for coil assembly removal to avoid the damage shown above.
