Service Bulletin

Bulletin No.: PIP5100

Subject: Allison LCT1000 Range Inhibit Or No Forward Reverse P0701 P0729 P0731 P0732 P0733 P0734 P0735 P0751 P0756 P0761 P0877 Or P2723 May Be Set

Models: 2011-2013 Chevrolet Silverado
2011-2013 GMC Sierra

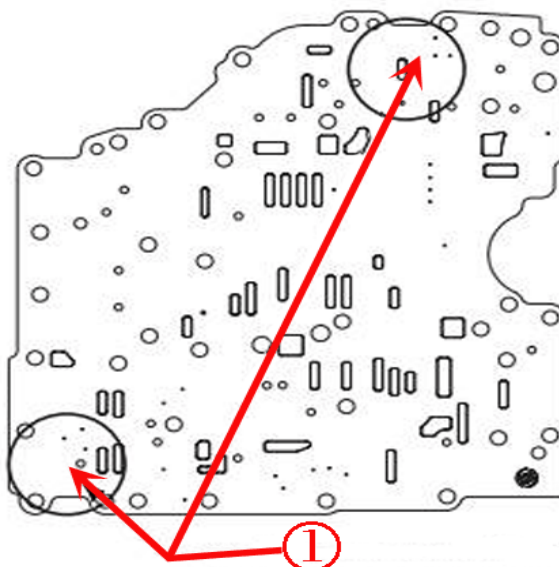
Call out 1

There are many possible locations where the plastic may lodge. The following are three locations seen on field returned transmissions:

Modulated main feed orifice- P0701 P0729 P0731 P0732 P0733 P0734 P0735 P0751 P0756 P0761 may set if this orifice is blocked.

PCS1 feed hole-An intermittent or no reverse condition can be exhibited when the PCS1 feed is blocked along with P2723 setting.

Reverse pressure orifice-Drive range may be inhibited along with P0877 setting.

Most common areas of blockage.

Always closely inspect the separator plate for this condition anytime the valve body is removed.

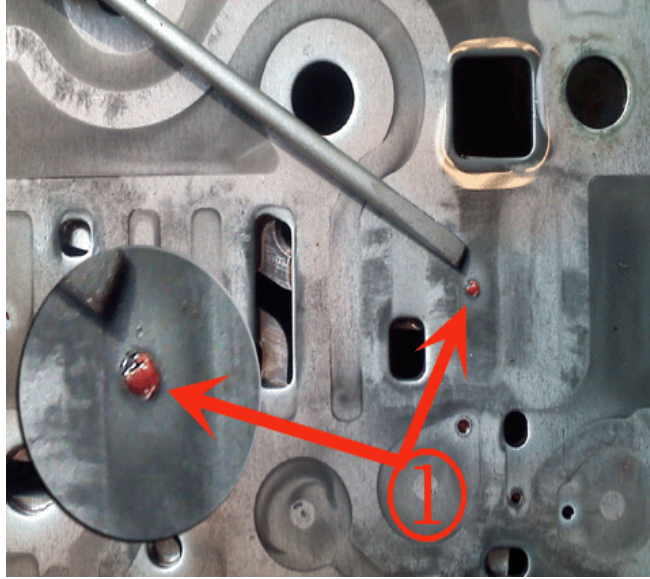
Call out 1

Many aftermarket spin-on filters are shipped with a protective shrink-wrap packaging that may inadvertently be introduced into the transmission during filter installation; this can contribute to a condition where the valve body separator plate orifices can become plugged.

Example of blockage.
