Service Bulletin

Bulletin No.: PIP5096

Subject: DTC P0024 Light With No Drivability Concerns

Models: 2012 Buick Lacrosse
2012 Cadillac SRX
2012 Chevrolet Captiva Sport
2012 Chevrolet Impala
with 3.0L LFW and 3.6L LFX engines

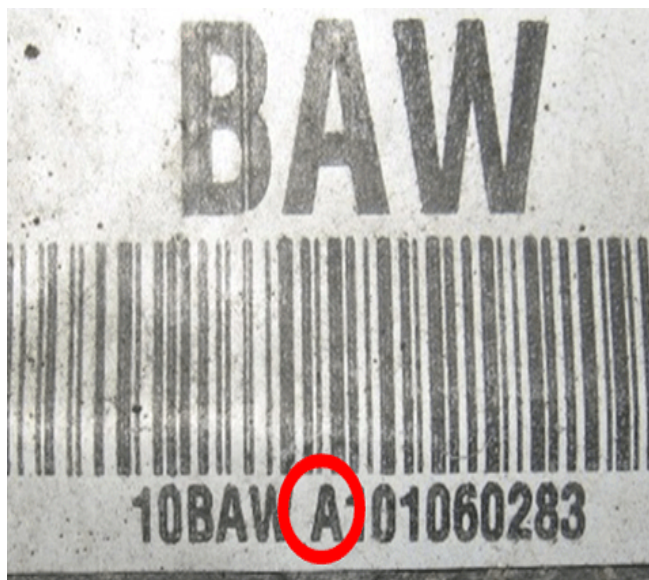
3291987

If you get a vehicle with this code, and no other drivability concerns, inspect the engine EUN sticker for an A before the sequence number; before replacing the actuator.

The engine EUN sticker should be located on the engine left side below the left head or on the back of the left head. (See the example below)

If there is an "A" before the sequence number then replace the OCV/Cam Actuator Solenoid Valve with a replacement "service" valve.

The service OCV is from a different supplier and can make up the difference in the clearance that causes this concern.
