Service Bulletin

Bulletin No.: PIP5036D

Subject: Possible Oil Consumption Or Blue Smoke From The Exhaust CEL Or Fuel Trim Codes

Models: 2011 Chevrolet Cruze
With 1.4L (RPO LUJ)
With one or more of the following DTCs P0106 P0171 P0299 P0507 P1101 P2096

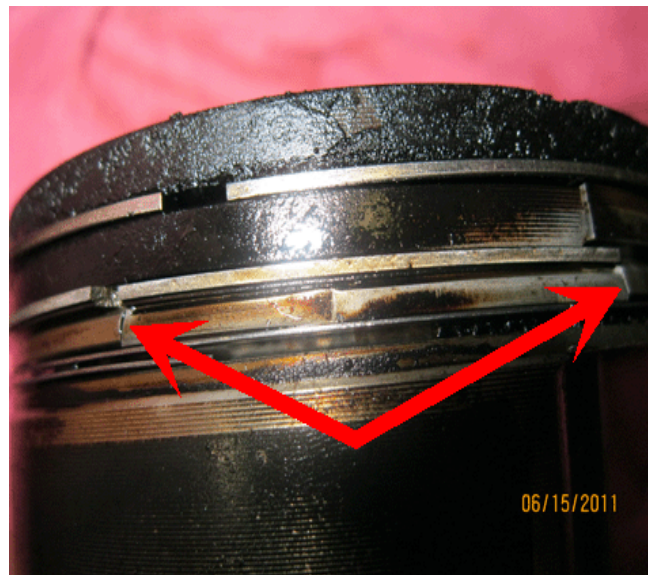
If low compression or high cylinder leakage values are recorded, remove all pistons and inspect ring condition and for cracks in the piston ring land between the number 2 compression ring and the oil control ring. See photo below

If the cylinder head is first design, then replace the cylinder head using the latest part number in the catalog.
Replace the pistons including new rings as needed using the latest part numbers in the catalog
Do not replace the engine for this concern unless cylinder wall or block damage is found.

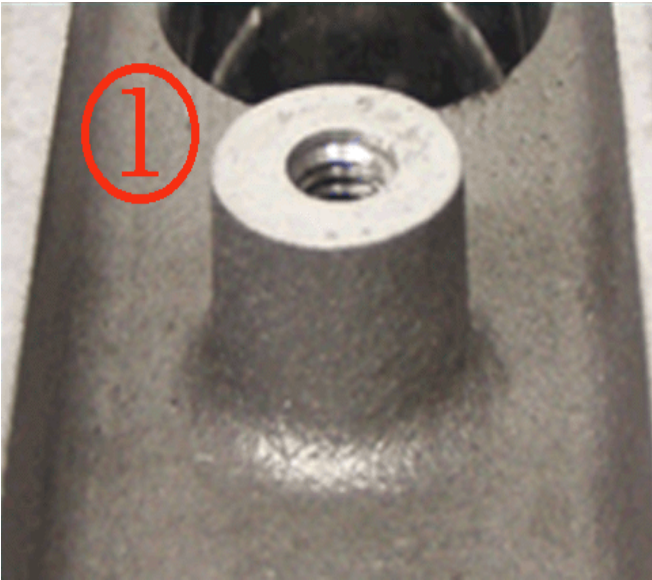
3281196

If cracked piston ring lands are found, then inspect the cylinder head to determine first or second design. See photos below.

First design (call out #1)

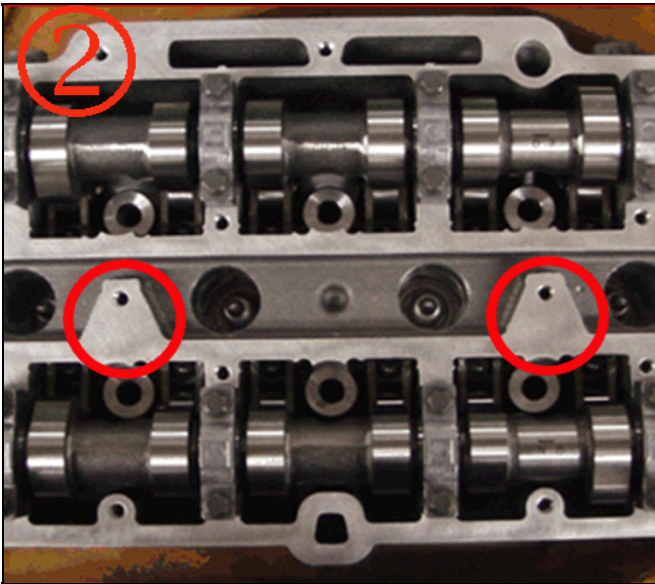
3281207

Second design (call out #2)
