Service Bulletin

Bulletin No.: PIP5029D

Subject: Engine Misfires due to Major Carbon Deposits on the Intake and or Exhaust Valves

Models: 2009-2014 Buick Enclave
2009-2014 Buick Lacrosse
2008-2014 Cadillac CTS, STS
2010-2014 Cadillac SRX
2013-2014 Cadillac ATS, XTS
2008-2010 Chevrolet Cobalt SS, HHR SS
2009-2014 Chevrolet Traverse
2010-2014 Chevrolet Camaro, Equinox
2011-2014 Chevrolet Captiva
2012-2013 Chevrolet Impala
2014 Chevrolet Impala, Impala Limited
2009-2014 GMC Acadia
2010-2014 GMC Terrain
2007-2010 Pontiac Solstice GXP
2009-2010 Saturn Outlook
2007-2010 Saturn Sky Redline

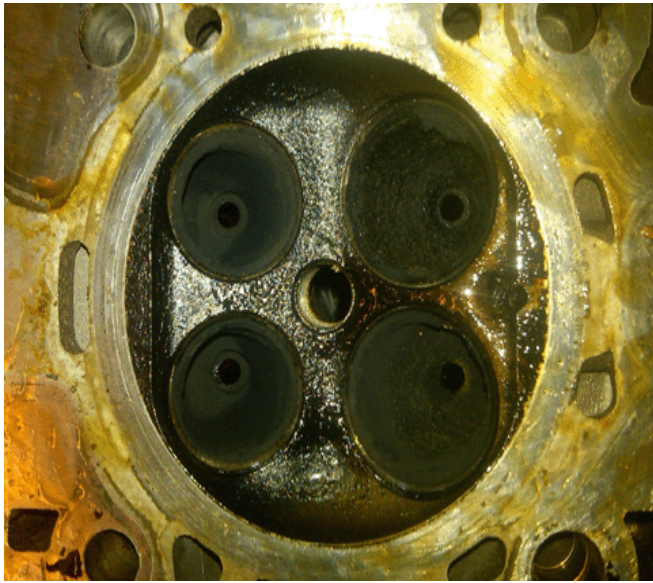
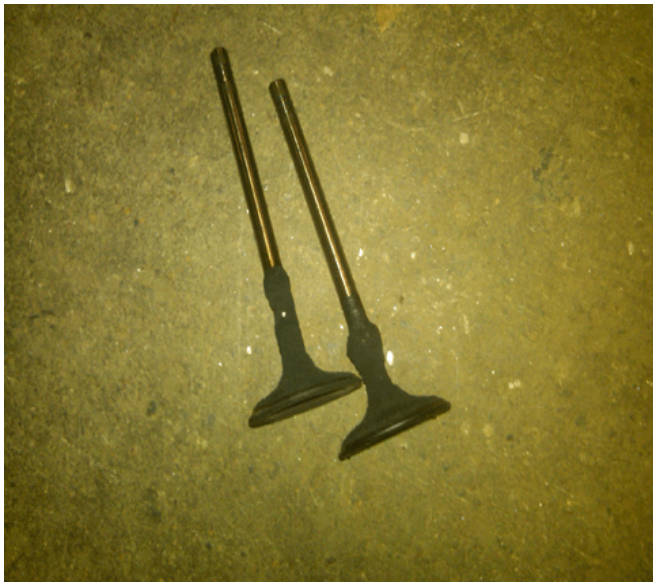
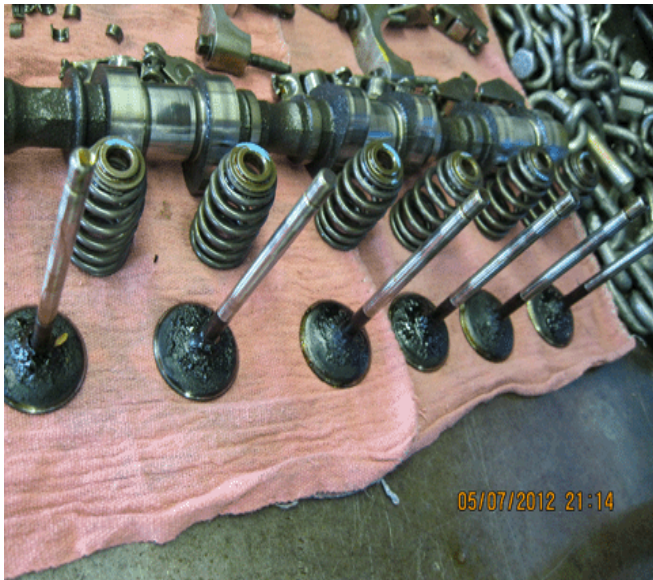
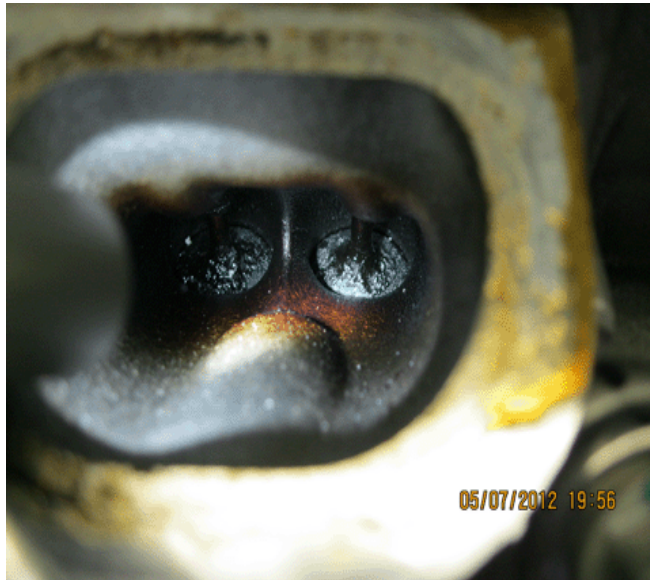
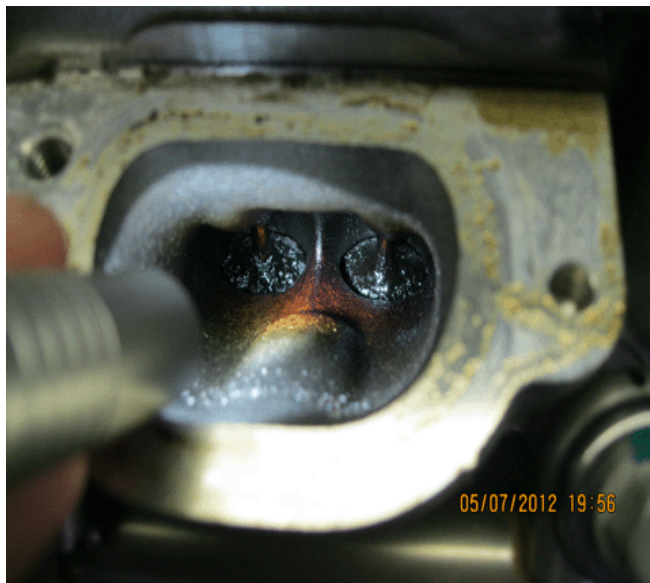
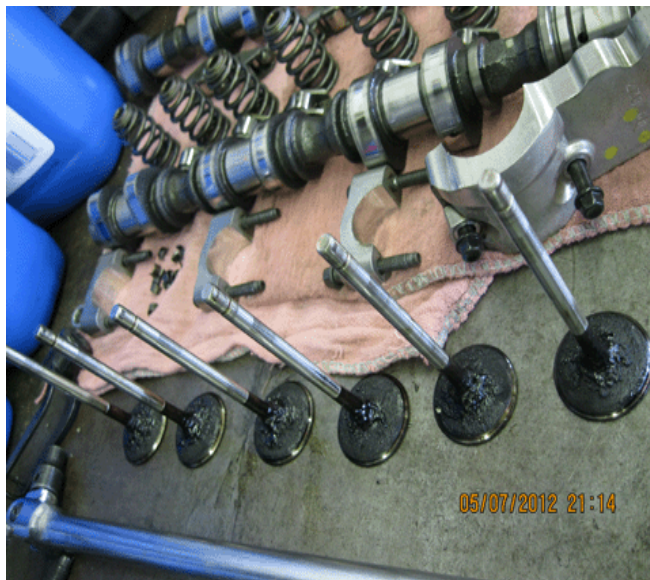
This may be the result of major carbon build up on the intake and/or exhaust valves as shown below so the misfires should not have appeared until accumulating at least 5,000 miles or more.

If this concern is encountered, perform SI diagnosis. If SI diagnosis isolates a valve sealing concern and/or eliminates everything else external to the engine, decarbon the engine with Upper Engine and Fuel Injector Cleaner by following the guidelines below:
