# Service Bulletin

Bulletin No.: PIP4972C

**Subject:** Allison LCT1000 Range Inhibit Or No Forward Reverse P0877 Or P2723 May Be Set

**Models:** 2001-2007 Chevrolet Silverado Classic  
2007-2010 Chevrolet Silverado  
2003-2009 Chevrolet Kodiak  
2001-2007 GMC Sierra Classic  
2007-2010 GMC Sierra  
2003-2009 GMC Topkick  
Equipped with the Allison LCT1000 Transmission RPO M74 or MW7

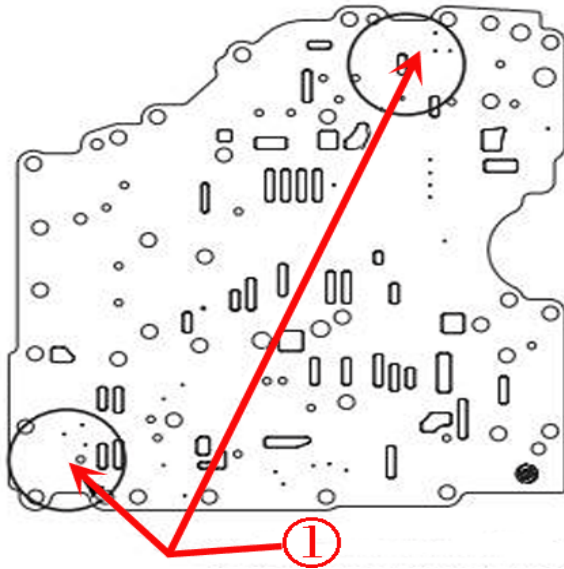
2900575

There are many possible locations where the plastic may lodge. The following are two locations seen on field returned transmissions:

PCS1 feed hole - An intermittent or no reverse condition can be exhibited when the PCS1 feed is blocked along with P2723 setting.

Reverse pressure orifice - Drive range may be inhibited along with P0877 setting.

Most common areas of blockage.

Many aftermarket spin-on filters are shipped with a protective shrink-wrap packaging that may inadvertently be introduced into the transmission during filter installation; this can contribute to a condition where the valve body separator plate orifices can become plugged. Always closely inspect the separator plate for this condition anytime the valve body is removed.

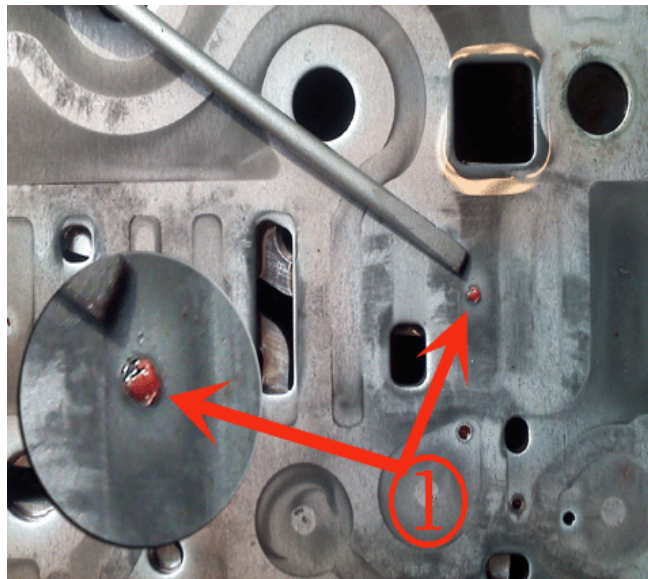
3287575

Example of blockage.
