# Service Bulletin

Bulletin No.: PIP4844B

**Subject:** TAC Part Restriction - Accessory Power Module (APM)

**Models:** 2011-2013 Chevrolet Volt

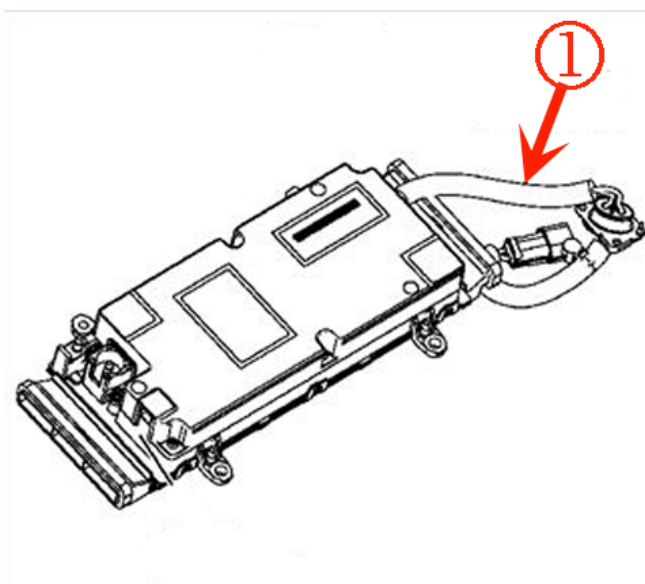
3256768

The first design APM has a 24 inch orange pigtail attached to the APM and there is no high voltage connection right at the APM itself (See Photo Below)

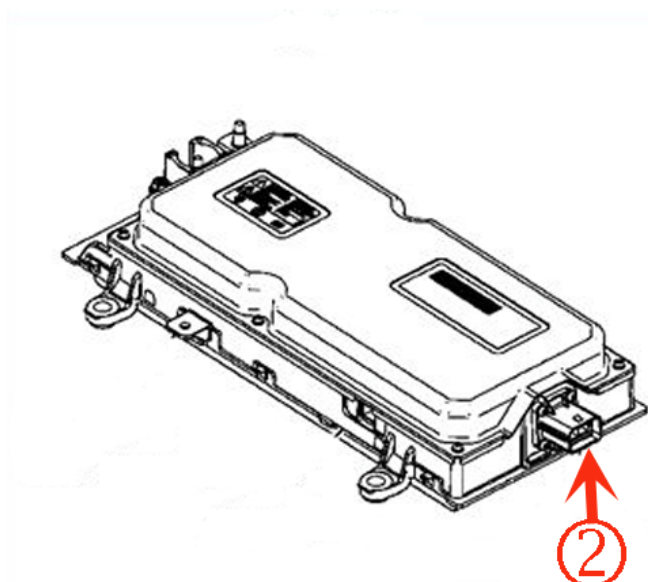
3256773

The second design APM has no pigtail and the high voltage connection is right at the APM itself (See Photo Below)
