Service Bulletin

Bulletin No.: PIP4568M

Subject: Tick Noise And/or Misfires On AFM Cylinders 1 4 6 And/or 7

Models: 2008-2009 Buick LaCrosse, Allure (Canada Only)
2007 Buick Rainier
2007-2013 Cadillac Escalade
2010-2013 Chevrolet Camaro SS
2007-2013 Chevrolet Avalanche, Silverado, Suburban, Tahoe
2006-2009 Chevrolet Trailblazer
2006-2009 Chevrolet Impala SS
2006-2007 Chevrolet Monte Carlo SS
2006-2009 GMC Envoy
2007-2013 GMC Sierra, Yukon
2008-2009 Pontiac G8
2005-2008 Pontiac Grand Prix GXP
2006-2009 Saab 97x
With a V8 Engine and AFM (Active Fuel Management):
RPO Codes L76, L77, L94, L99, LC9, LFA, LH6, LMG, LS4, LY5, LZ1

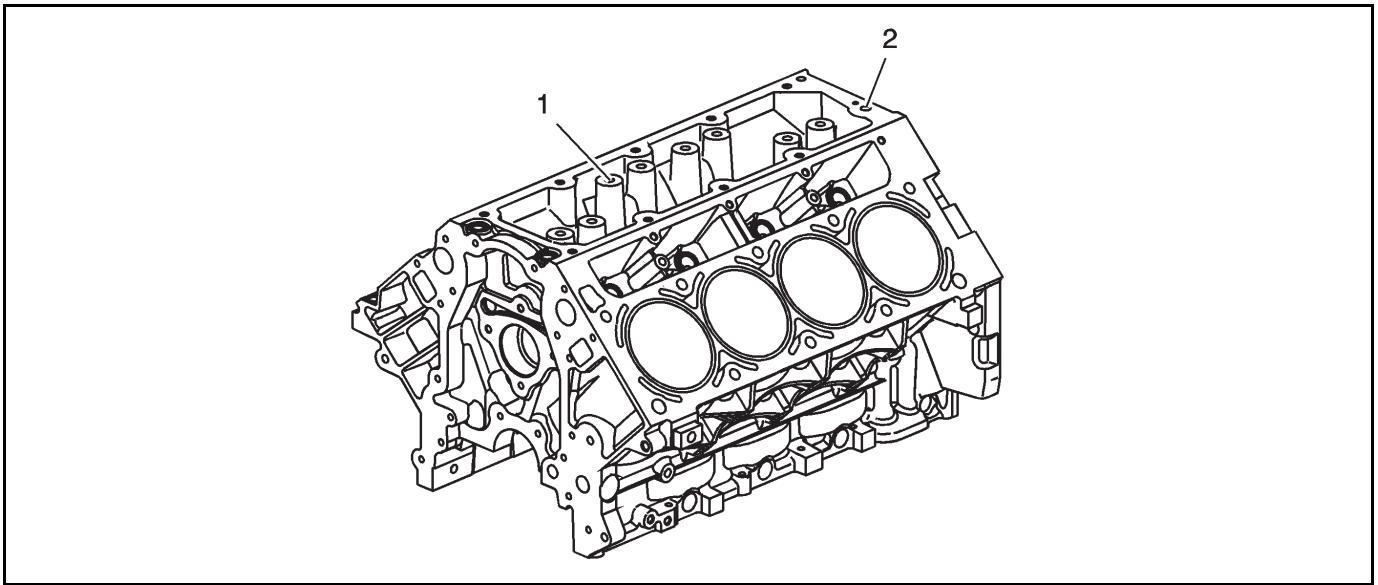
1403340

- Clean out the related lifter control oil passages (item 1 below) while the old lifters are removed. Generally, it is only necessary to blow through the passages with shop air but if a lot of debris is noted, it may also be necessary to flush the passages out with brake cleaner. The oil should be changed after doing this since the cylinder heads will be off to replace the lifters anyhow.
