Service Bulletin

Bulletin No.: PIP5038B

Subject: SES Light, Engine Misfire, and/or Shudder - Inspect Ignition Coils

Models: 2009 Buick Enclave
2008-2009 Cadillac CTS, STS
2009 Chevrolet Traverse
2009 GMC Acadia
2009 Saturn Outlook
With Direct Injected 3.6L V6 Engine (RPO LLT)

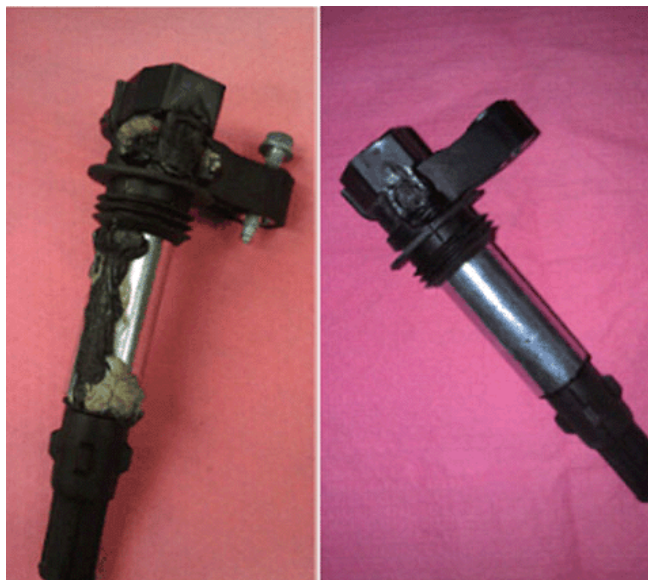
3419856

This may be the result of a heat stressed/damaged ignition coil.

The coil damage could be due to the ECM latching "ON" the associated coil EST (dwell) line.

Dwell times greater than 50msec will result in coil damage (see photos)

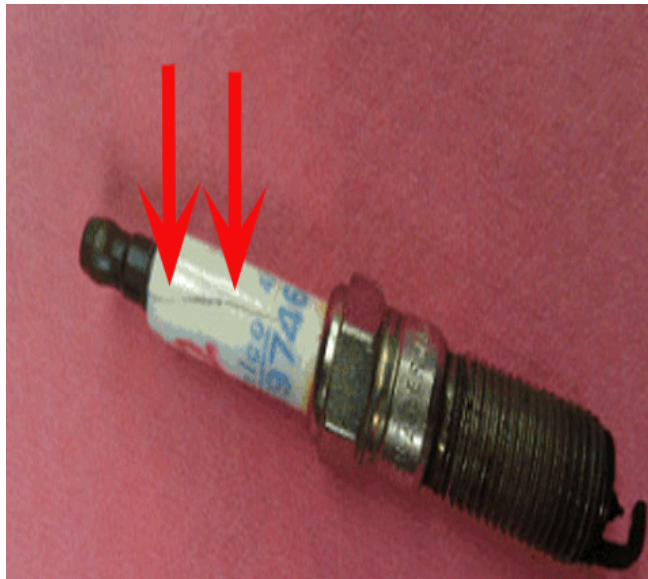
3419858

Spark plugs that are cracked, wrong plug gap, worn plugs, carbon fouling, and top post contact issues.

Corrosion - all prevents the coil charge to produce a healthy spark, which could reflect EMI transient back to the ECM.

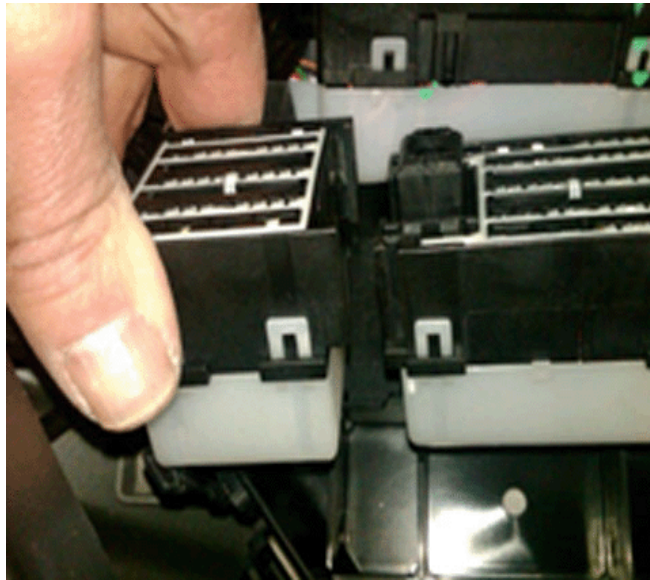
3419859

U BEC (Under Hood Body Electrical Center) - Poor connector engagement on bottom of the UBEC, loose terminal fits and low pin drag can cause intermittent transient.

X1 and X3 Connectors slide together. Connectors must be fully seated.

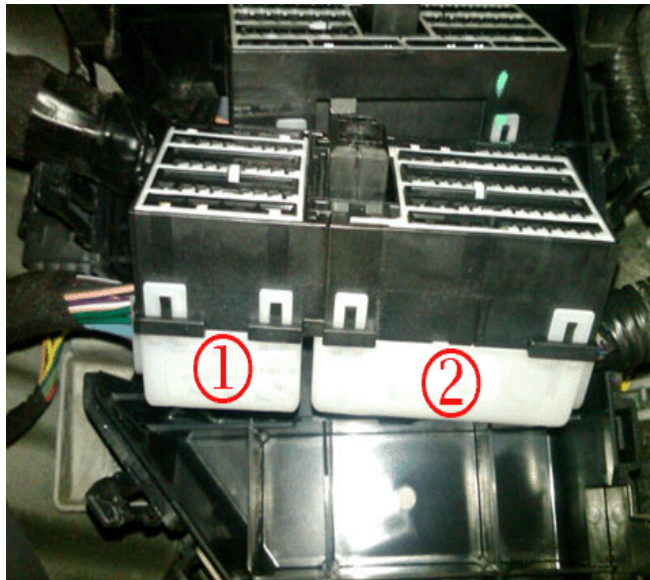
3419861

1) Connector 1 2) connector 3

Check Coil terminal cavities for proper pin drag and fit.

Connections: Cavity 47-Even bank and 51 Odd Bank Ignition Coil – All Models

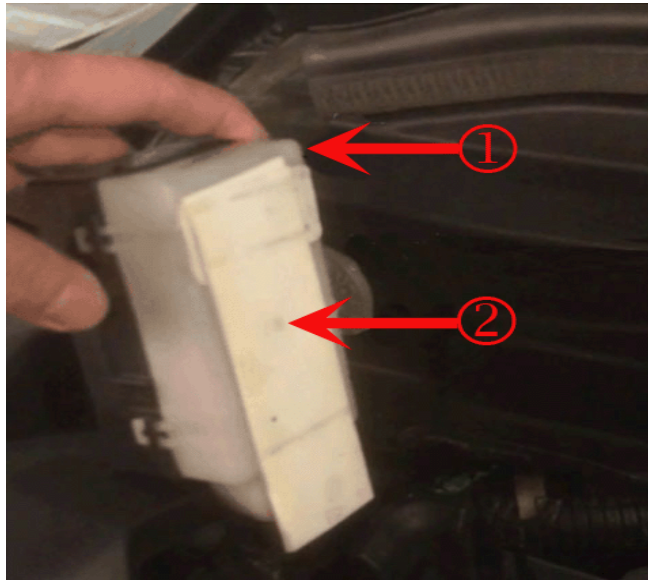
3419862

1) Engine harness connector - UBEC 2) Foam tape used to support connector to UBEC in addition to assembly fasteners.

Assembly Aid: By adding a small stripe of Foam or Felt tape 2 mm thick to the back of electrical connections and bottom of the UBEC tray. The Tape provides additional stack up height between the tray and correctors for better connector terminal engagement. Once X1 / X3 connectors, are seated in the upper UBEC, hand tighten the assembly bolt, an indicator flag should become visible on top of the upper UBEC half.

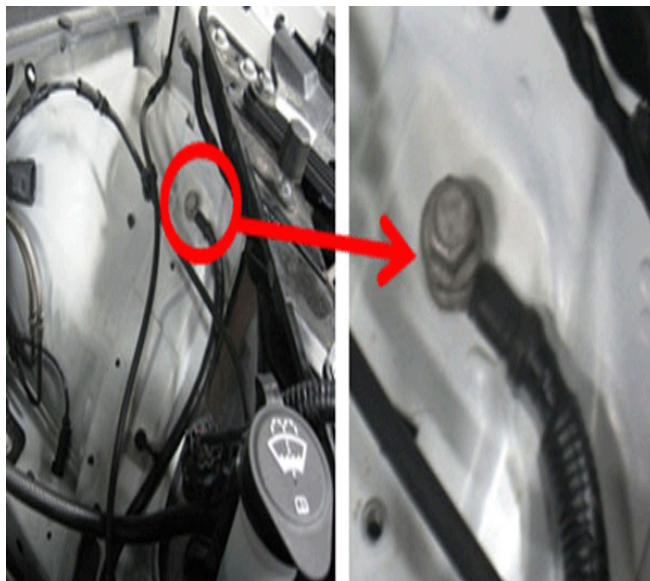
3419867

Enclave, Acadia, Traverse and Outlook shown as picture example:

CTS and STS: Negative battery cable at battery and cable to body bolt. – Clean both sides of the terminal and mounting surface. Must be free of corrosion at mounting, terminal, attachment bolt surfaces.
