Service Bulletin

Bulletin No.: PIP5036E

Subject: Possible Oil Consumption Or Blue Smoke From The Exhaust CEL Or Fuel Trim Codes

Models: 2013 Buick Encore
2011-2013 Chevrolet Cruze
2012-2013 Chevrolet Sonic
2013 Chevrolet Trax
With 1.4L (RPO LUJ or LUV)
With one or more of the following DTCs P0106 P0171 P0299 P0507 P1101 P2096

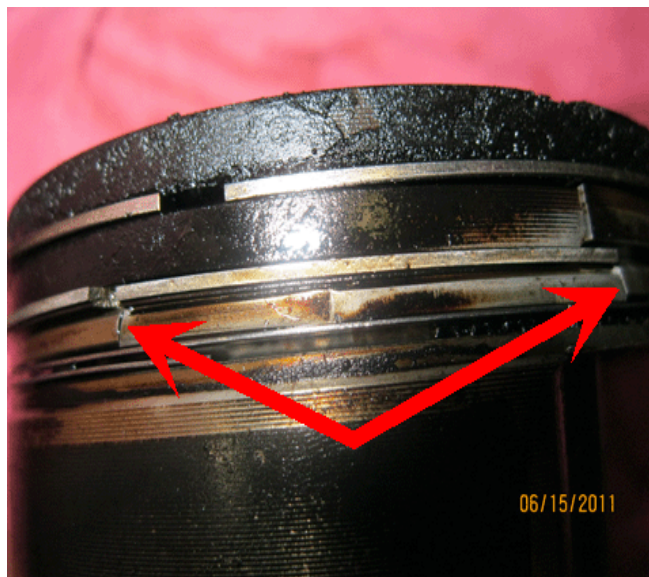
3278922

If no air leaks are found, remove all pistons and inspect ring condition and for cracks between the number 1 and 2 compression ring lands. See photo below:

If the cylinder head is first design, then replace the cylinder head using the latest part number in the catalog.
 Replace the pistons including new rings as needed using the latest part numbers in the catalog.
 Do not replace the engine for this concern unless cylinder wall or block damage is found.

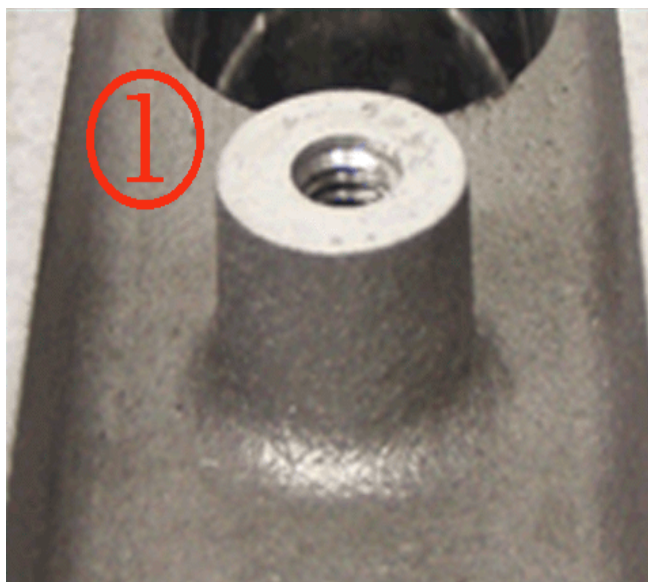
3281196

If cracked piston ring lands are found, then inspect the cylinder head to determine first or second design. See photos below:

First design (call out #1)

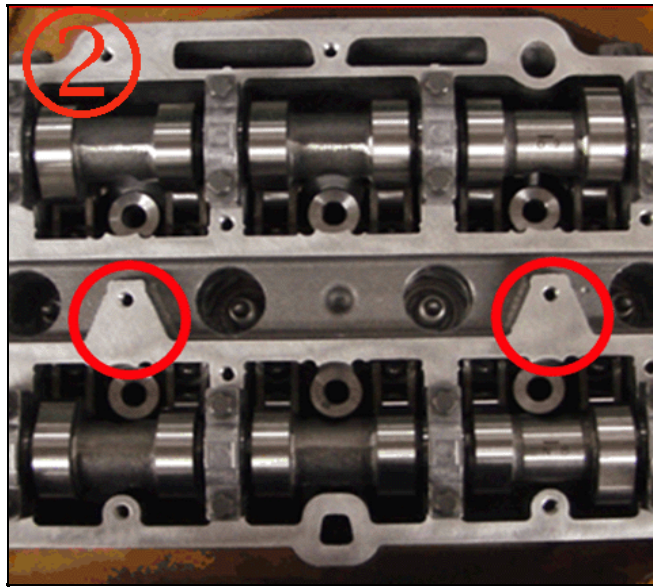
3281207

Second design (call out #2)
