Service Bulletin

Bulletin No.: PIP3394F

Subject: Duramax Diesel Injector Driver Codes

Models: 2004-2005 Chevrolet Kodiak, Silverado
2004-2005 GMC Sierra, Topkick
with 6.6 Engine (VIN 2 - RPO LLY)

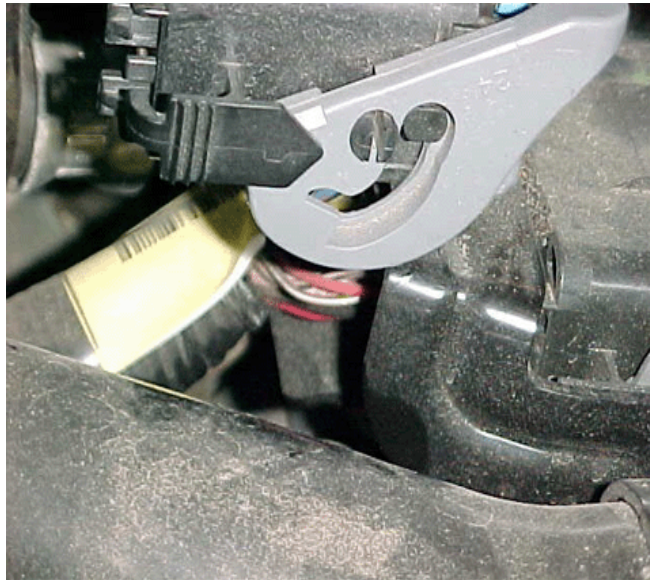
3415783

1. Diagnose all injector driver codes using the current SI diagnostics.
2. If all SI diagnostics are inconclusive, inspect for wire chafes at the Fuel Injector Control Module (FICM) wiring harness brace. The wiring harness brace is located 4 to 6 inches away from the FICM connectors. The wiring harness is nylon tied to the wiring harness brace. It may be necessary to remove the nylon tie to inspect the harness. Repair any wire chafes following SI wire repair procedures. Insulate the harness with wiring conduit or a suitable material so the wires will not chafe again.

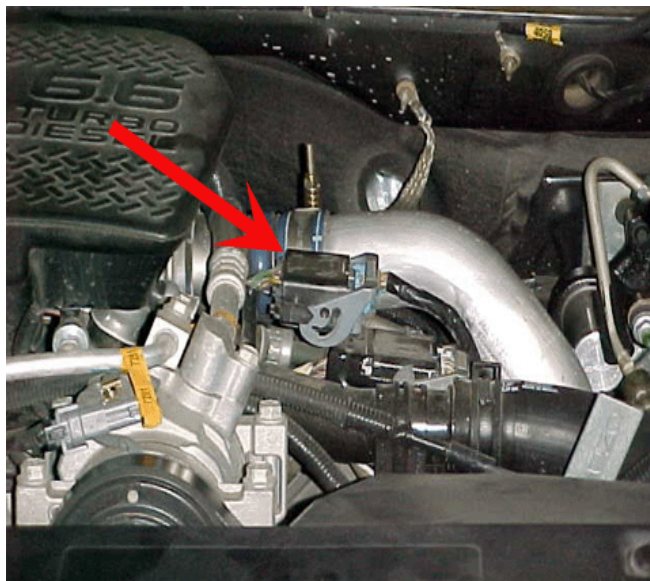
3415784

3. Also inspect the C107 (Silverado and Sierra) or C118 (Kodiak and Topkick) connector for wire chafes. The C107 (Silverado and Sierra) or C118 (Kodiak and Topkick) connector is found above the left (driver side) rocker cover. The wiring harness may relax and lay on top of the C107 (Silverado and Sierra) or C118 (Kodiak and Topkick) support brace. This support brace is located right below the C107 (Silverado and Sierra) or C118 (Kodiak and Topkick) connector. Repair any wire chafes following SI wire repair procedures. Insulate the harness with wiring conduit or a suitable material so the wires will not chafe again.
