Service Bulletin

Bulletin No.: PIE0272A

Subject: Engineering Information – Sunroof Sunshade Binding, Tearing or Ripping

Models: 2014 Chevrolet Impala with RPO C3U Sunroof

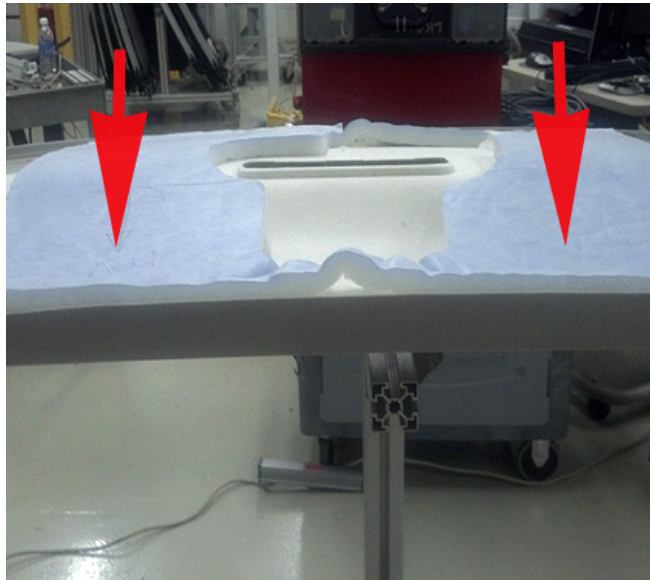
3632342

1. Lower the headliner trim panel (do not remove the headliner). Refer to Headlining Trim Panel Replacement (With Sunroof) In SI.

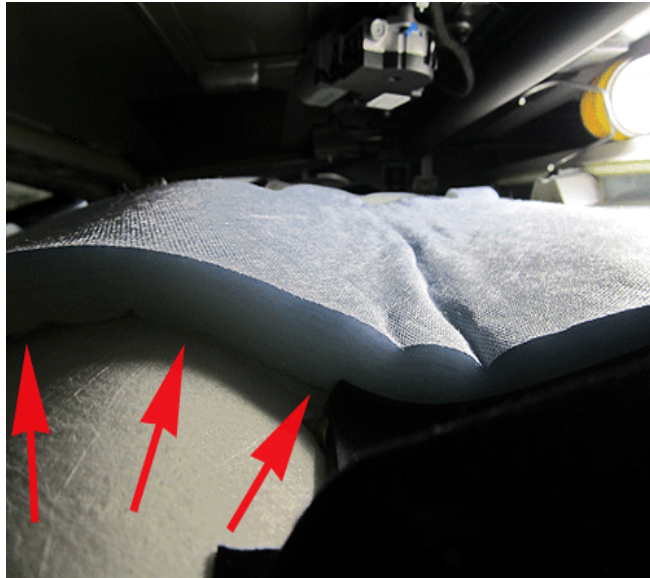
3632343

2. Provide pictures of the inside of the rear headliner showing the blue/white acoustical pad in the following areas:

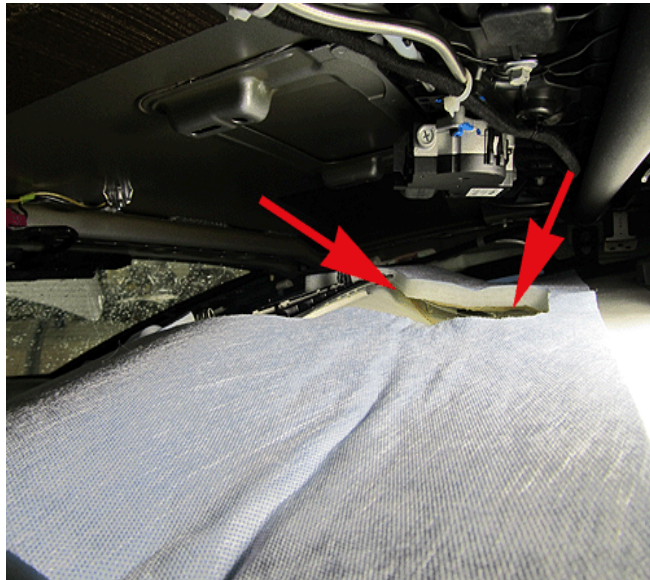
3632344

- Inspect to verify the acoustical material is adhered to the headliner and following the contour of the headliner for the full width of the pad.

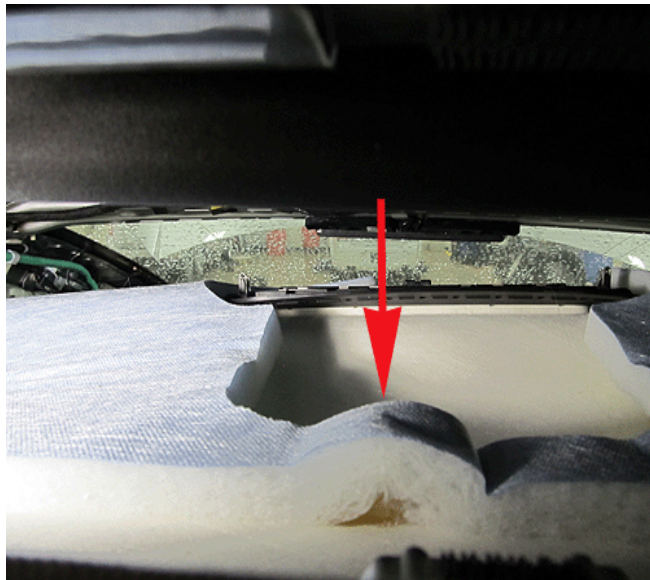
3632346

- Determine if the acoustical pad is **not** adhered to the headliner and is gaping the contour of the headliner.

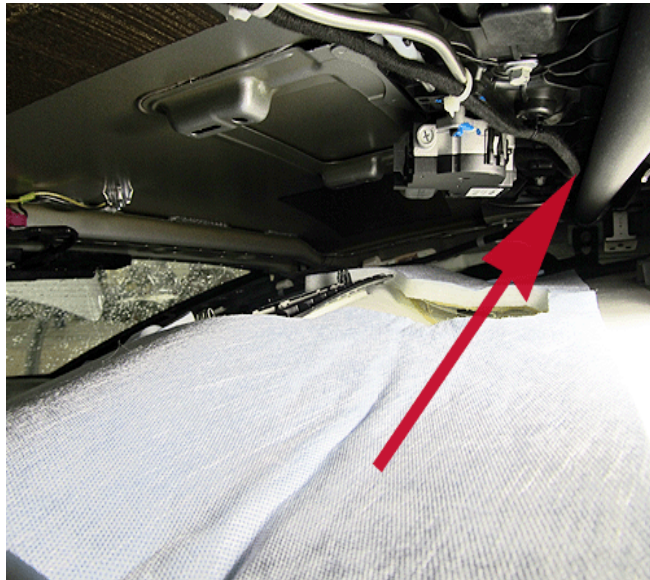
3638248

- Determine if the material is bunching in the center.

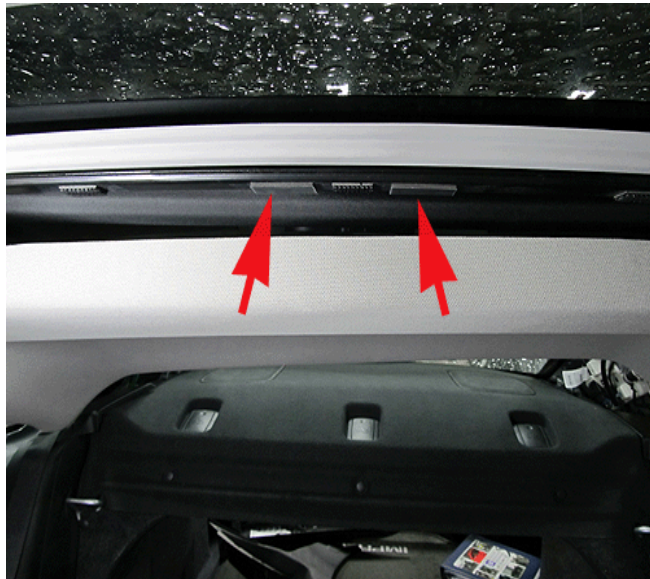
3632347

3. Provide pictures of the inside rear headliner area showing the motor wiring harness to sun shade roller clearance.
 - Note if it appears that the harness is contacting or has contacted the sun shade material on the roller.
