Service Bulletin

Bulletin No.: PIE0272

Subject: Engineering Information – Sunroof Sunshade Binding, Tearing or Ripping

Models: 2014 Chevrolet Impala with RPO C3U Sunroof

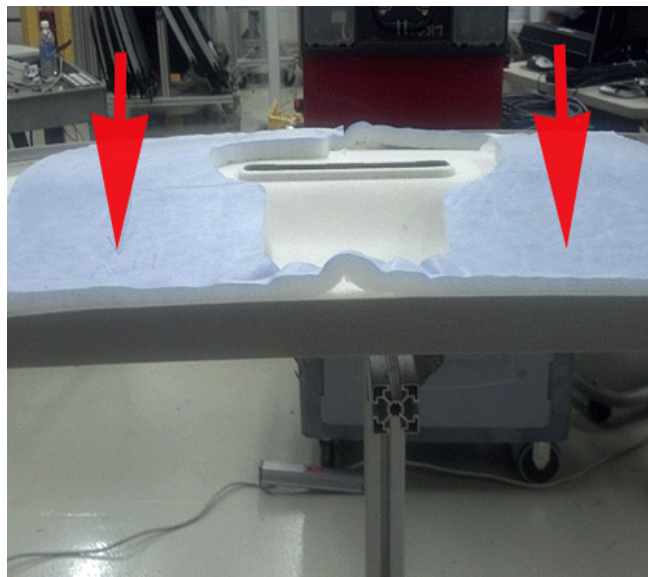
1. Lower the headliner trim panel (do not remove the headliner). Refer to Headlining Trim Panel Replacement (With Sunroof) In SI.

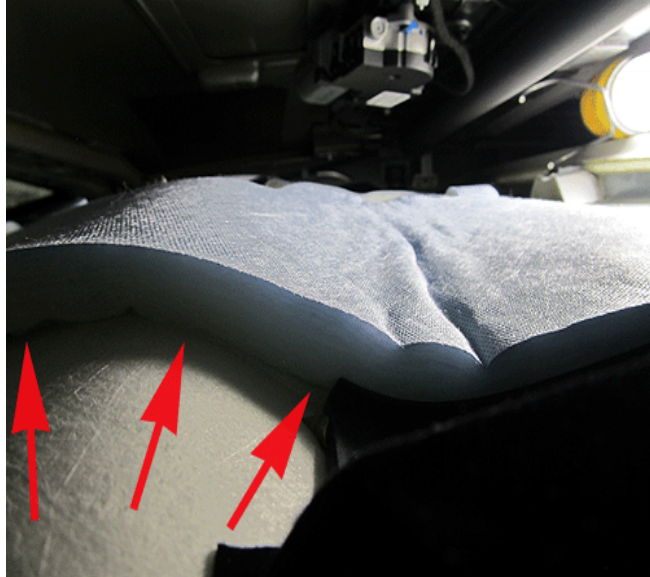
3632343

- Inspect to verify the acoustical material is adhered to the headliner and following the contour of the headliner for the full width of the pad.

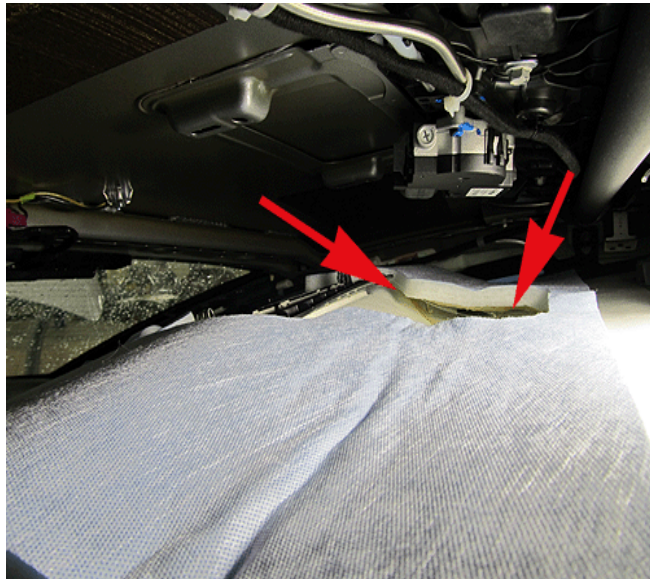
3632344

- Determine if the acoustical pad is **not** adhered to the headliner and is gaping the contour of the headliner.

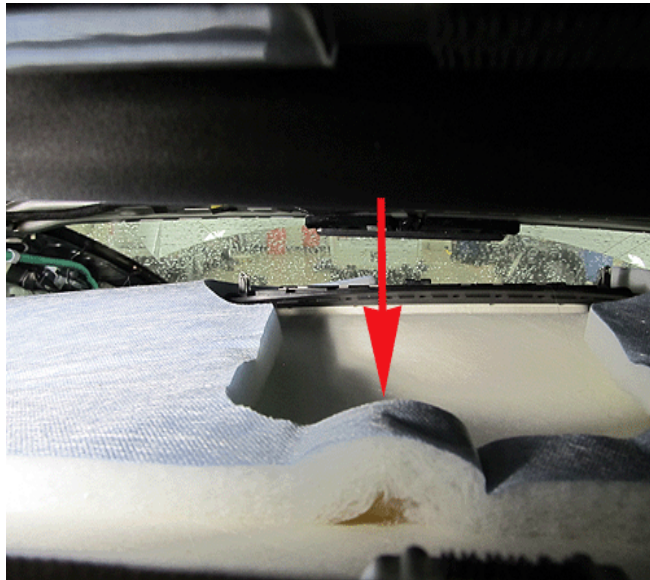
3632346

- Determine if the material is bunching in the center.
