Service Bulletin

Bulletin No.: PIE0256

Subject: Engineering Information – Active Grille Aero Shutter Malfunction

Models: 2013 Cadillac ATS with RPO XFE

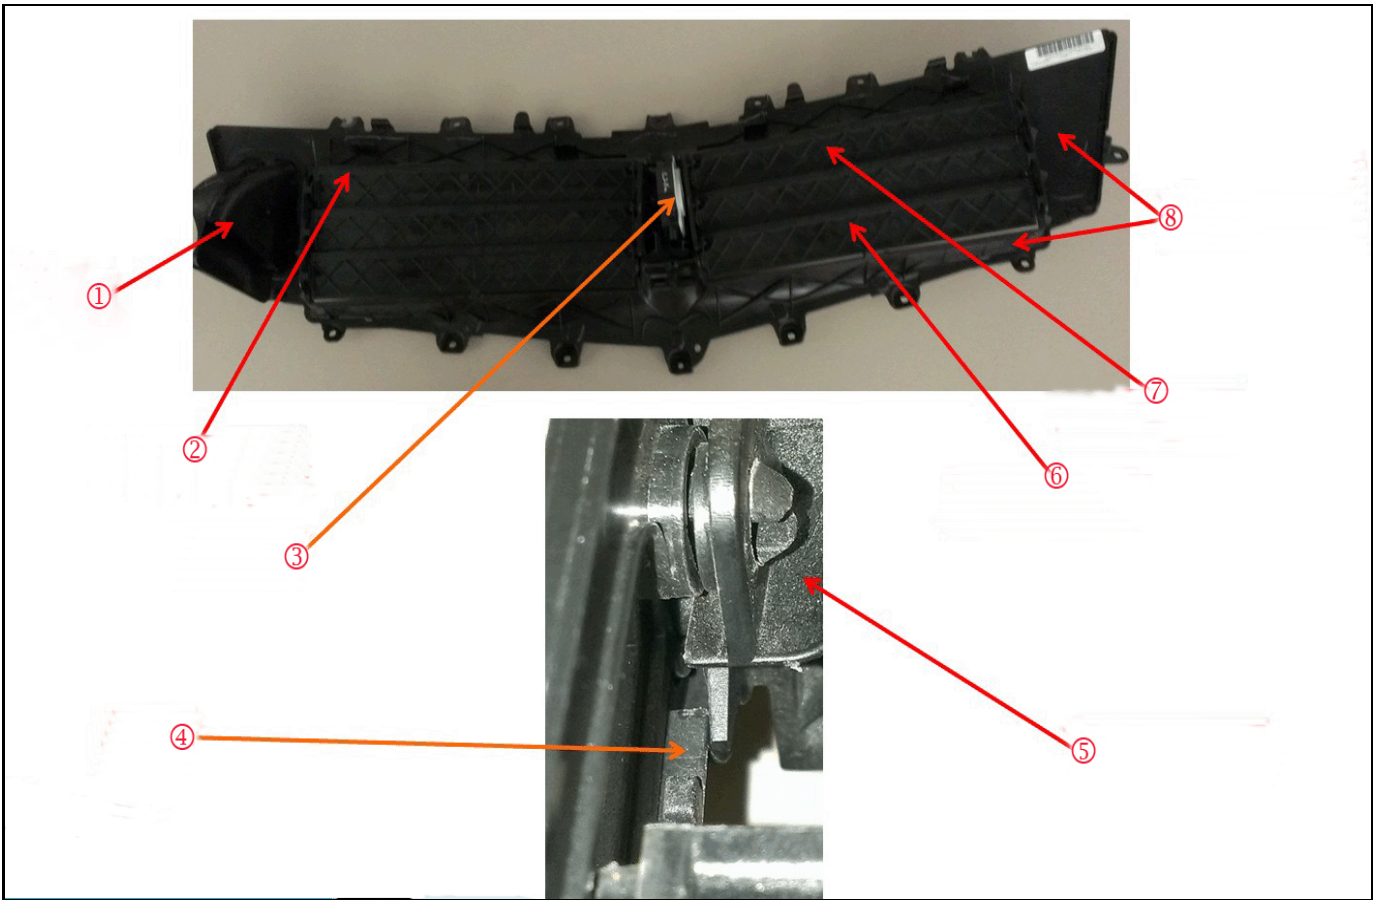
3413866

- 1. Duct
- 2. Upper Louver
- 3. Actuator
- 4. Stop
- 5. Drive Louver
- 6. Lower Louver
- 7. Drive louver
- 8. Shutter Frame

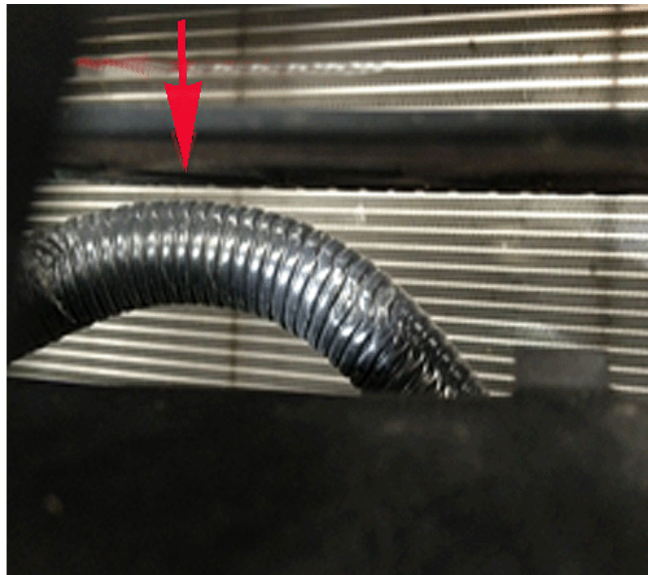
3407117

Prior to removing the fascia, check for wire harness interference. Document the contact condition if present.

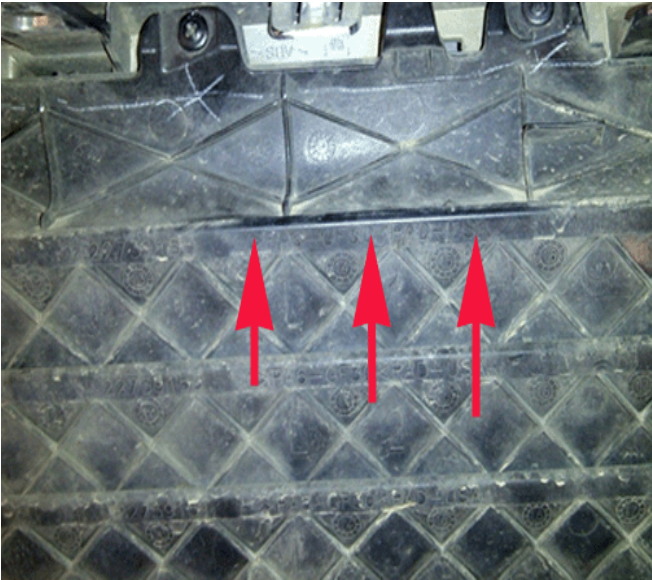
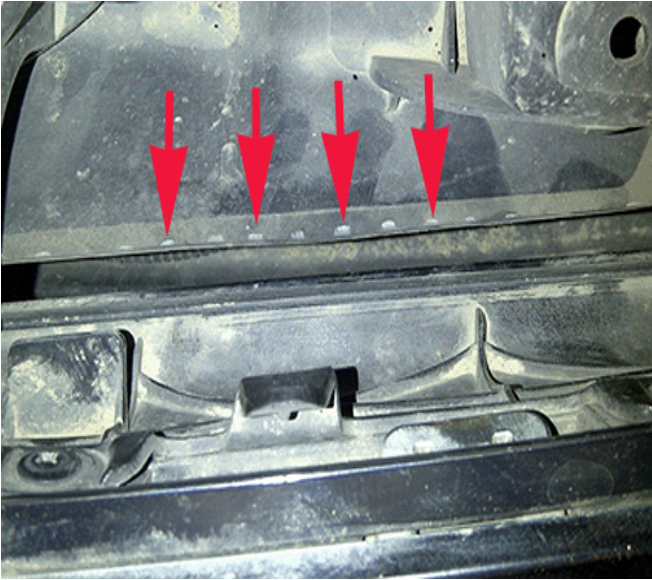
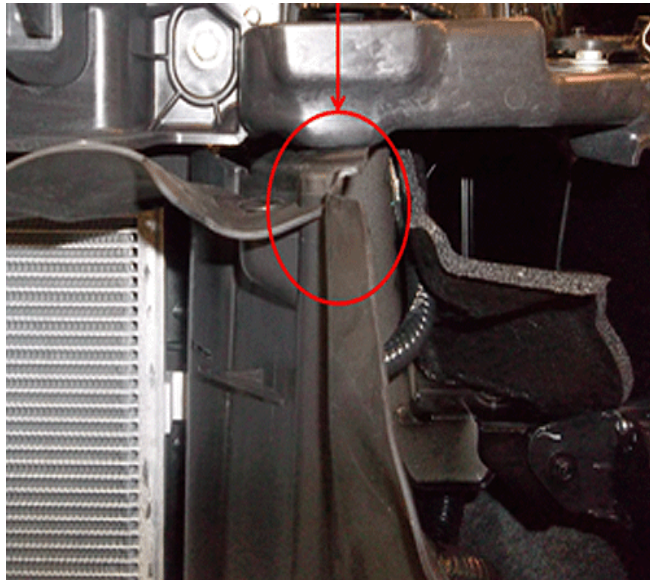
- 1. Check for debris blocking the movement of the louvers.

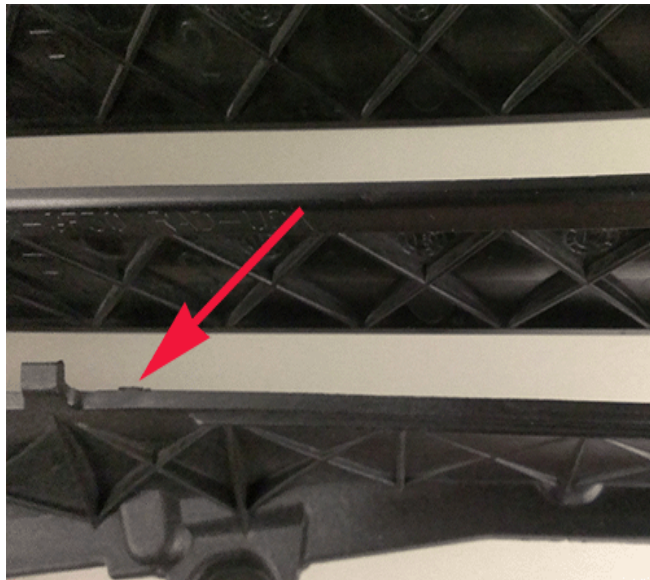
3407126

2. Check for baffle interference. Look for rubbing marks on the baffle and edge of the louver.

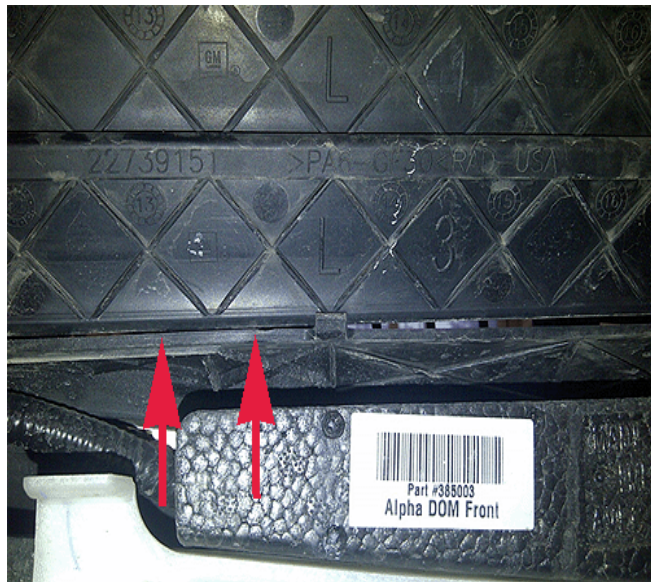
3407133

3. Check for flash at the bottom of the frame.

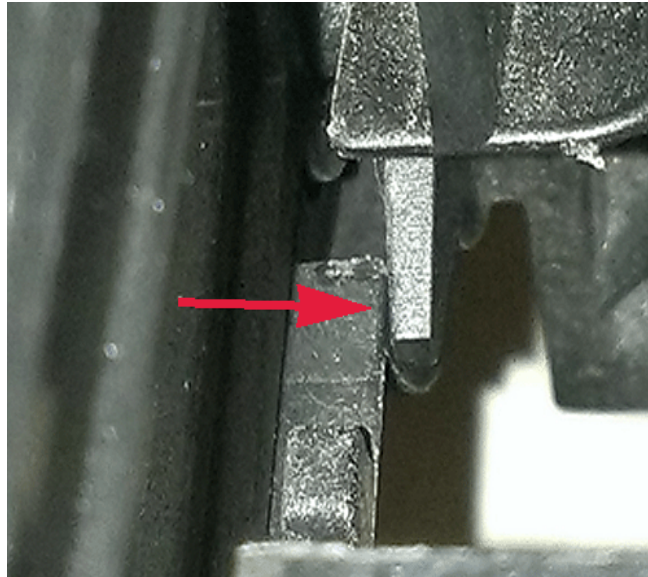
3407137

4. Check to see if the louver is caught on the lower edge of the shutter frame. This is seen while the shutter is still attached to the fascia.

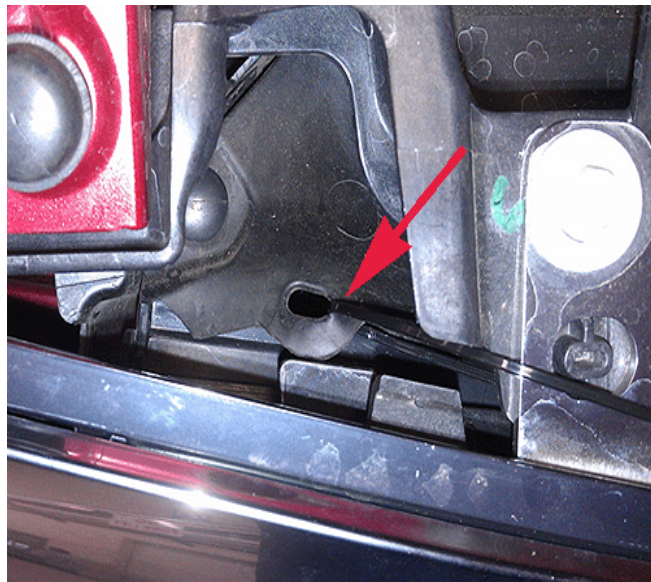
3407140

5. Check to see if the drive louver is over-rotating past the stop.
