Service Bulletin

PRELIMINARY INFORMATION

Subject: Engineering Information – Active Grille Aero Shutter Malfunction

- Models: 2013 Cadillac ATS with RPO XFE
- Attention: Proceed with this PI ONLY if the customer has commented about this concern AND the PIE number is listed in the Global Warranty Management / Investigate History link (GWM/IVH). If the customer has not commented about this condition or the EI does not show in GWM/IVH, disregard the PI and proceed with diagnostics found in published service information. THIS IS NOT A RECALL refer to the latest version of Service Bulletin 04-00-89-053 for more details on the use of Engineering Information PIs.

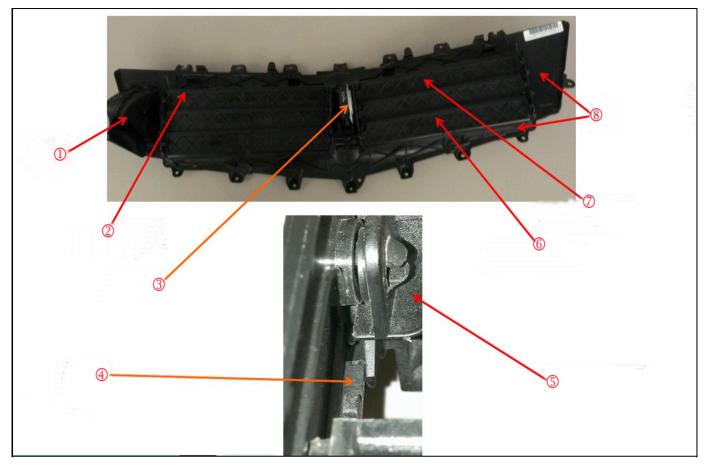
- 1. Duct
- 2. Upper Louver
- 3. Actuator
- 4. Stop
- 5. Drive Louver
- 6. Lower Louver
- 7. Drive louver
- 8. Shutter Frame

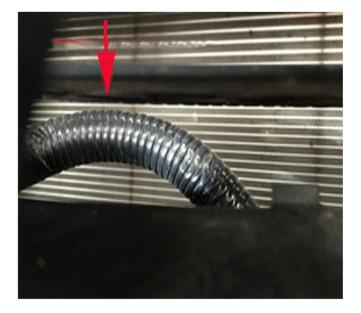
Prior to removing the fascia, check for wire harness interference. Document the contact condition if present.

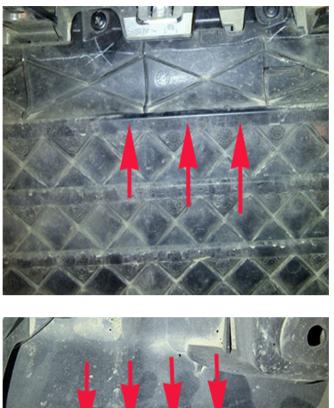
3407123

1. Check for debris blocking the movement of the louvers.

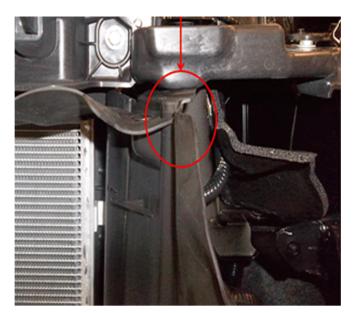
3407121

2. Check for baffle interference. Look for rubbing marks on the baffle and edge of the louver.

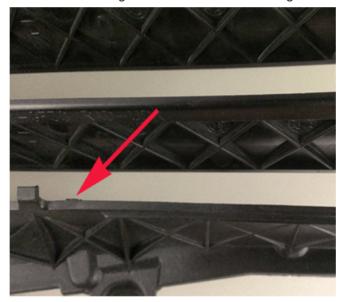
3. Check for flash at the bottom of the frame.

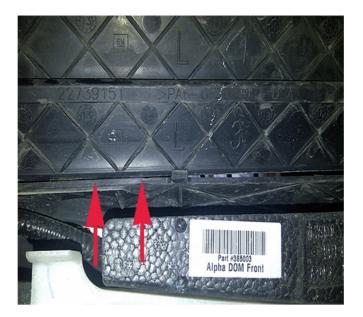
3407126

4. Check to see if the louver is caught on the lower edge of the shutter frame. This is seen while the shutter is still attached to the fascia.

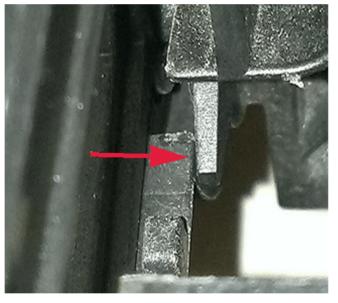
3407137

5. Check to see if the drive louver is over-rotating past the stop.
