NUMBER: 08-059-13

Flash: Hands Free Module Defaults To English Instead Of Last Language Selected

2012	(JC)	Journey (International only)
2012	(LD)	Charger (International only)
2012	(LX)	300 (International only)

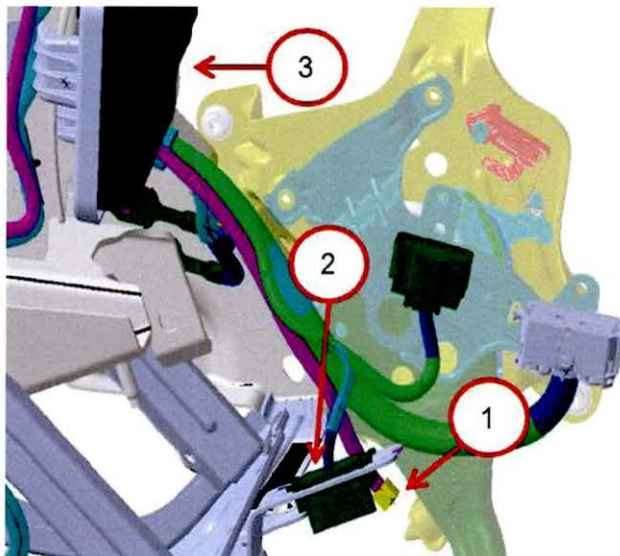
Fig. 1 JC USB Connector Location

- 1 - Delphi 4-Way connector (connect wiTECH USB Cable here)
 - 2 - Diagnostics Connector
 - 3 - Hands Free Module
-

NOTE: For JC vehicles, the wiTECH cable is plugged into the Delphi 4-Way USB connector which is located next to diagnostic connector on the driver side(Fig. 1). For the LD or LX vehicles the wiTECH USB Cable is plugged directly into the HFM Module which is located above the driver's side kick panel (Fig. 2).

5. Connect the wiTECH USB Cable to the HFM USB connector only, do not connect Cable to the PC until instructed by wiTECH.

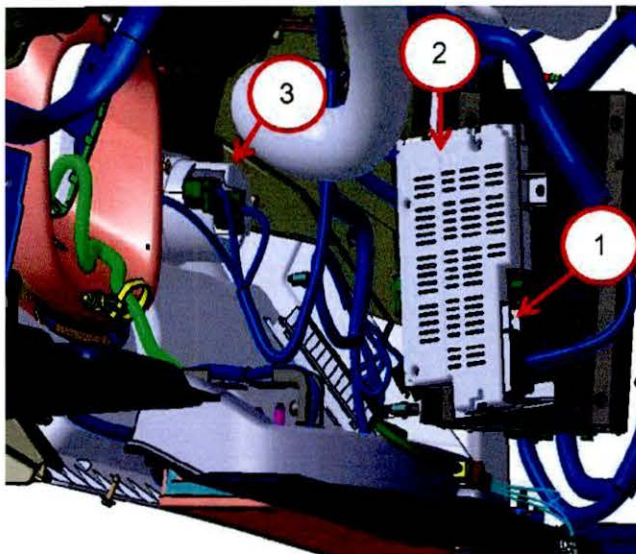
Fig. 2 LD and LX USB Connector Location

- 1 - USB Connector Cavity
- 2 - Hands Free Module
- 3 - Headlamp Switch

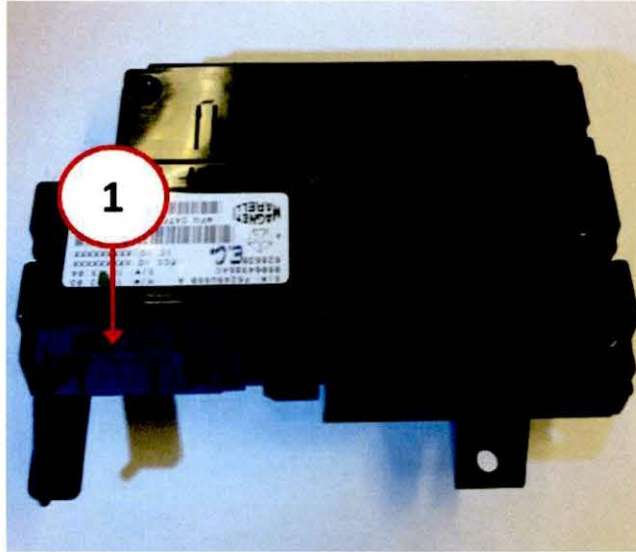
Fig. 3 HFM Module

1 - C1 Connector Cavity

NOTE: A module reset may be required in the event that an abort recovery is necessary. Procedures vary slightly between LD/LX and JC. LD/LX module power will be reset by removing the C1 connector from the HFM, see (Fig. 3). On JC vehicles, the module power will be reset by removing fuse F131 from the passenger side fuse block, see (Fig. 4).

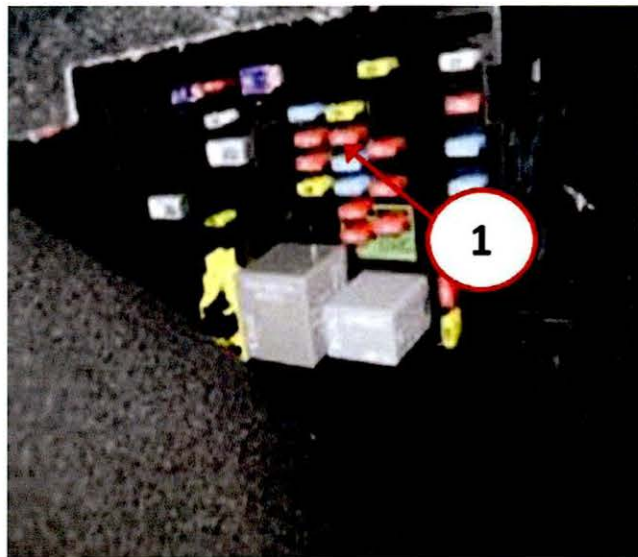
Fig. 4 JC Passenger Side Fuse Block

1 -Fuse F131
