NUMBER: 23-002-13 REV. A

Rattle And/Or Clunking Sound From Convertible Top

2011-2012 (JS) Chrysler 200

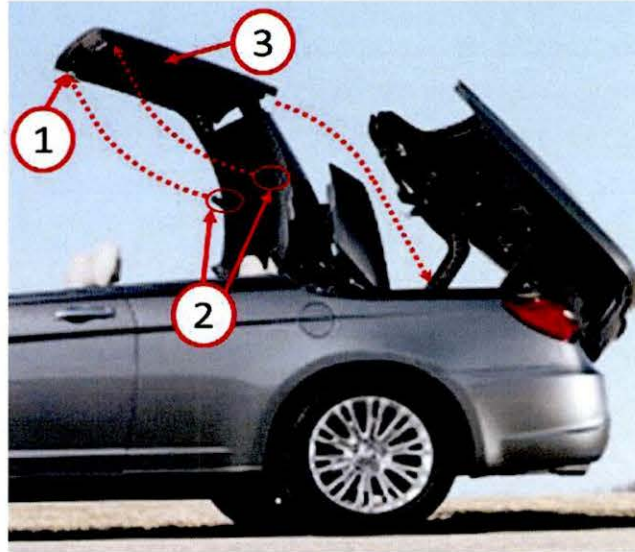
Fig. 1 Hard Top Down Capture System

The hard top assembly is equipped with a down capture mechanism which locks it into the stowed position when lowered. If the hook assembly (2) does not fully engage the down capture mechanism (1) the roof assembly may produce a rattle or clunk due to insufficient retention of the hard top at the hook assembly(Fig. 1). If the customer describes the symptom, perform the Repair Procedure.

- 1 - Front Down Capture Mechanism (Latches to C-Pillar Hook Assembly)
 2 - Down Capture Hook Assembly (Retracts From Upper C-Pillar)
 3 - Down Capture Receiver Rod/Latch Assembly (Located Under Headliner)

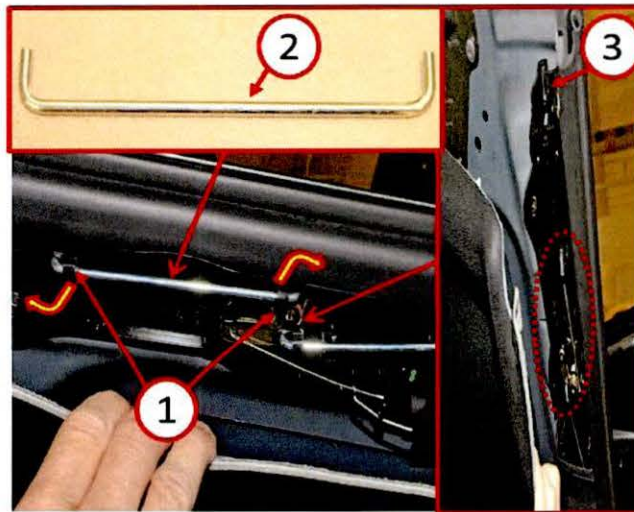
Fig. 2 Down Capture Receiver Rod Replacement

- 1 - Retaining Clips (Secure Receiver Rod)
- 2 - Receiver Rod (Actuates Down Capture Latch)
- 3 - Down Capture Mechanism (Located Under Headliner / Latch Protrudes Out Forward Edge)

- a. Yes >>> Proceed to **Step #3**.
 - b. No >>> Proceed to **Step #4**.
3. Replace the damaged or bent receiver rod(s) by swinging the retaining clips open and pulling the rod out of the clips (**Fig. 2**).

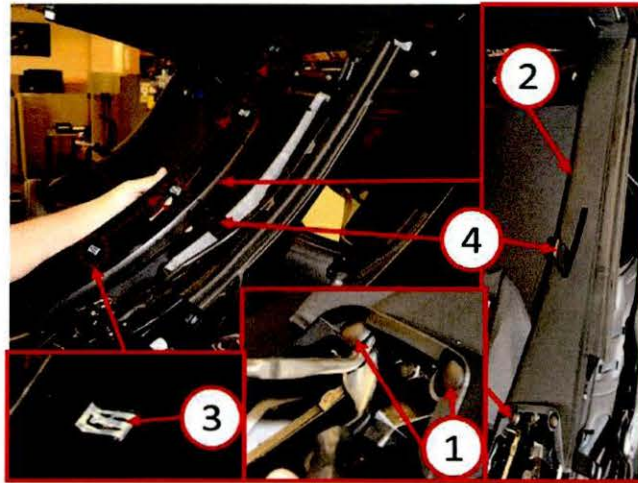
Fig. 3 Upper C-Pillar Trim Removal

- 1 - Plastic Push Clips (2 Retain End of C-Pillar Trim)
- 2 - C-Pillar Trim (Covers Down Capture Hook Assembly)
- 3 - Metal Push Clips (4 Retain C-Pillar Trim)

-
4. Remove the upper C-pillar trim (2) from both the left and right side of the hard top assembly to gain access to the down capture hook assembly (4) (**Fig. 3**).

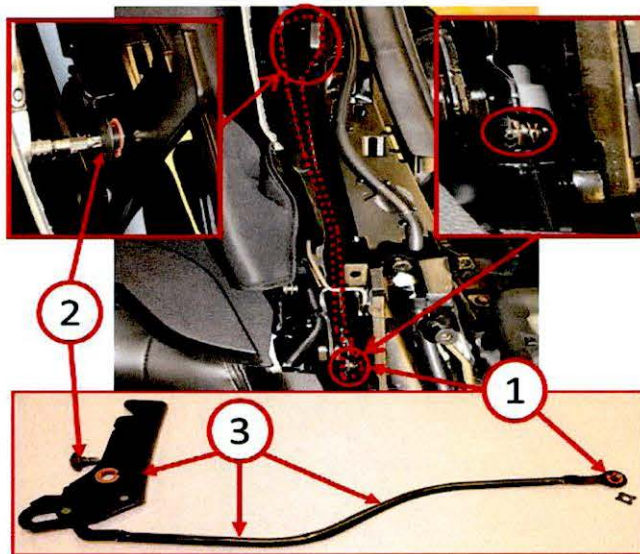
Fig. 4 Side Rail Down Capture Hook Replacement

- 1 - Push Clip Retainer and Pin Clevis
- 2 - Torx Shoulder Bolt
- 3 - Side Rail Down Capture Hook Assembly

-
5. Remove the push clip retainer and pin clevis (1) along with the torx shoulder bolt (2) (Fig. 4) to replace the side rail down capture hook assembly with the appropriate side/color specific revised part indicated in the parts section.
