NUMBER: 23-002-13 REV. B

GROUP: Body

Rattle And/Or Clunking Sound From Convertible Top

2011-2013 (JS) Chrysler 200

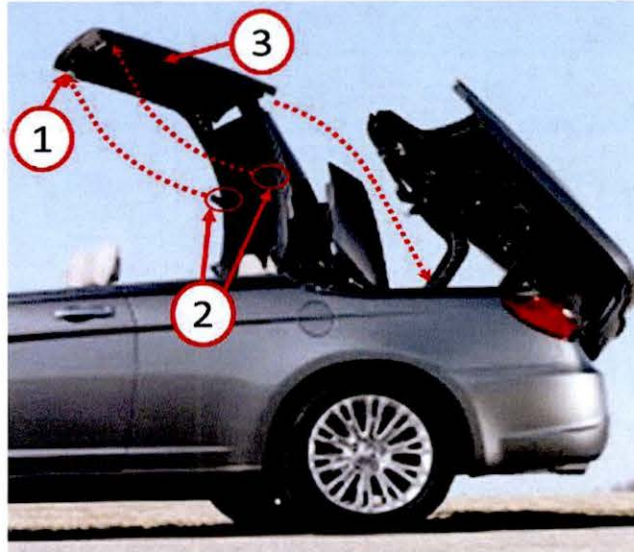
Fig. 1 Hard Top Down Capture System

The hard top may produce a rattle noise coming from the down capture receiver rod/latch assembly (3) while the hard top is in the up position. The hard top may also produce a clunk noise while in the stowed position when lowered due to insufficient retention of the hard top if the hook assembly (2) does not fully engage the down capture mechanism (1) (Fig. 1). If the customer describes the symptom, perform the Repair Procedure.
