NUMBER: 23-002-13

Rattle And/Or Clunking Sound From Convertible Top

2011-2012 (JS) Chrysler 200

NOTE: This bulletin applies to Chrysler 200 hard top convertible models only (sales code VRO).

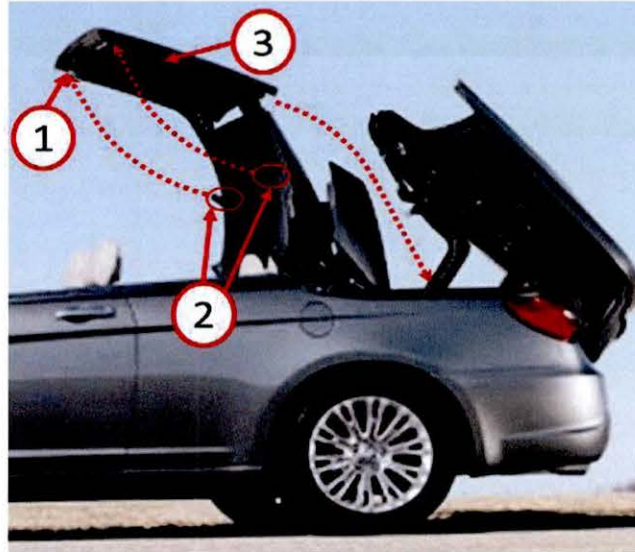
Fig. 1 Hard Top Down Capture System

The hard top assembly is equipped with a down capture mechanism which locks it into the stowed position when lowered. If the hook assembly (2) does not fully engage the down capture mechanism (1) the roof assembly may produce a rattle or clunk due to insufficient retention of the hard top at the hook assembly (Fig. 1). If the customer describes the symptom, perform the Repair Procedure.

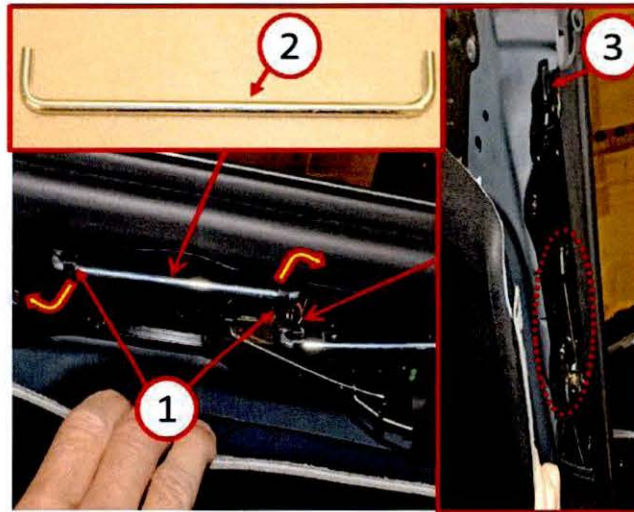
Fig. 2 Down Capture Receiver Rod Replacement

1. Pull the headliner back at the side weatherstrip seal on each side of the forward most hard top roof panel and inspect the forward most down capture receiver rod on each of the down capture latch assemblies.
2. Were either of the right and/or left side receiver rods bent and/or damaged?

- a. Yes >>> Proceed to **Step #3**.
 - b. No >>> Proceed to **Step #4**.
3. Replace the damaged or bent receiver rod(s) by swinging the retaining clips open and pulling the rod out of the clips (**Fig. 2**).
