**NUMBER:** 23-004-13

Right And/Or Left Rear Door Contacts Inner Quarter Panel

2011-2012 (LX) 300

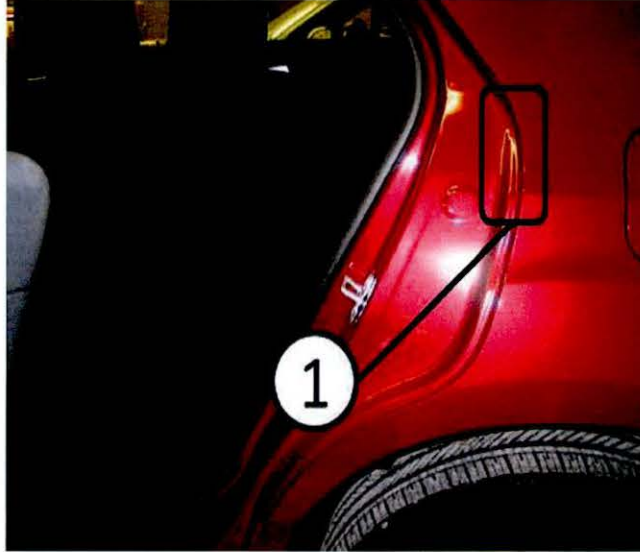
**Fig. 1 Left Rear Door**

1. Is the right and/or left door contacting the inner quarter panel at the area shown in (Fig. 1)?
  - a. Yes>>> Proceed to [Step #2](#).
  - b. No>>> Continue further diagnosis, this bulletin does not apply.

1 - Door Contact Area

**NOTE: The contact areas of the door and quarter panel will need to be polished to remove any marring. If paint is chipped, touch-up paint will need to be applied.**

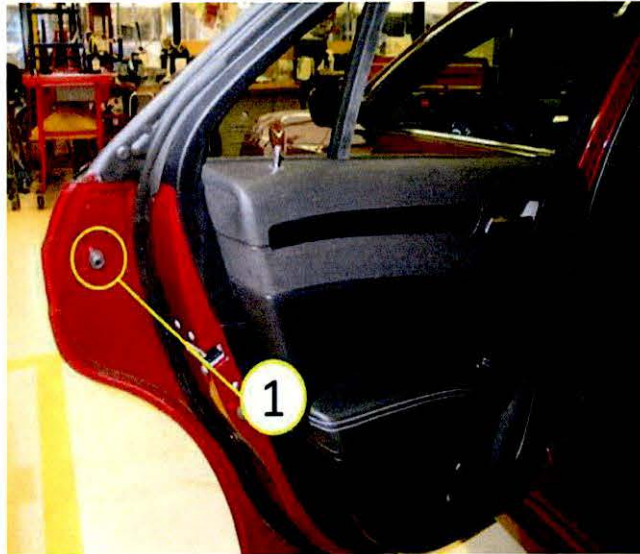
**Fig. 2 Left Rear Door**

1 - Rear Door Bump Stop

2. Replace the rear door bumper stop(s) with p/n 05020813AB as shown in (Fig. 2).

3. Adjust the door to quarter panel fitment 0.5mm over flush.
