NUMBER: 23-006-13

Waterleak At The Rear Of The Headliner

****2009 - 2012**** KK

Liberty

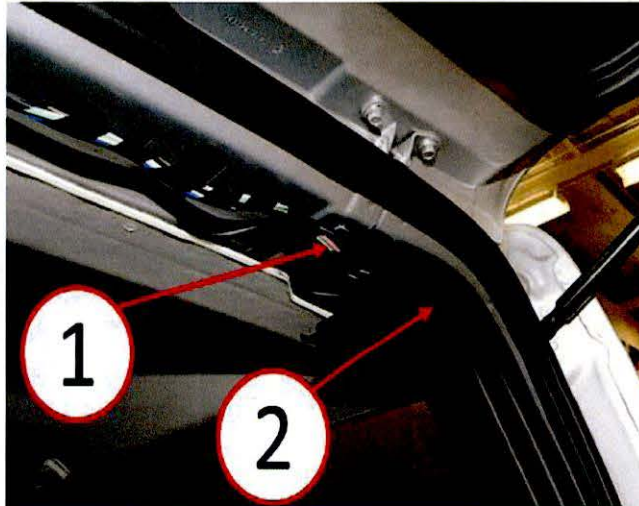
Fig. 1 Trim Panels - Right Side Shown

1 - Rear Headliner Trim Panel Location

2 - Inner Quarter Trim Panel

1. Open the tailgate and remove the headliner trim piece at the tailgate opening (1) and partially remove the interior quarter trim panel (2) where the waterleak is suspect(Fig. 1).

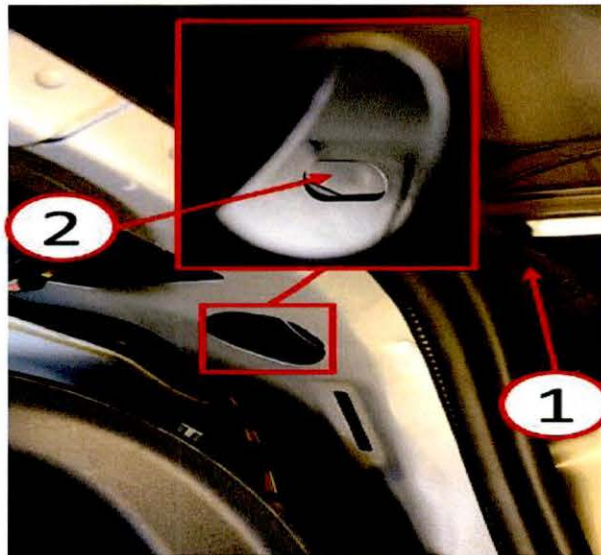
Fig. 2 Waterleak Inspection - Right Side Shown

The customer may notice the headliner is wet in either the right or left rear corners.

- 1 - Right Rear Quarter Panel
 - 2 - Suspect Water Leak Area
-

2. Perform a water flow test for 20 minutes at the rear of the vehicle and inspect for any water leaking at the rear inner quarter panel of the right and/or left side as shown in (Fig. 2).
3. Was there any water leaking?
 - a. Yes >>> Proceed to [Step #4](#).
 - b. No >>> Continue further diagnosis, this bulletin does not apply.

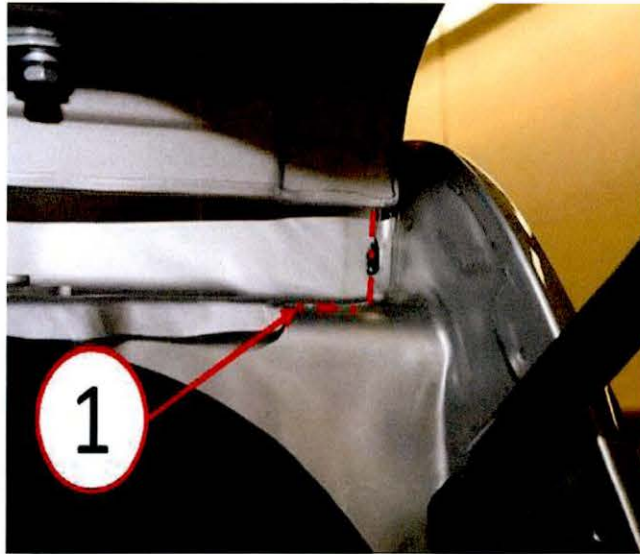
Fig. 3 Sealer Application Area - Right Side Shown

1 - Clean This Area

4. Clean the roof ditch seam at the right and/or left side with isopropyl alcohol and a lint free cloth as designated in (Fig. 3)

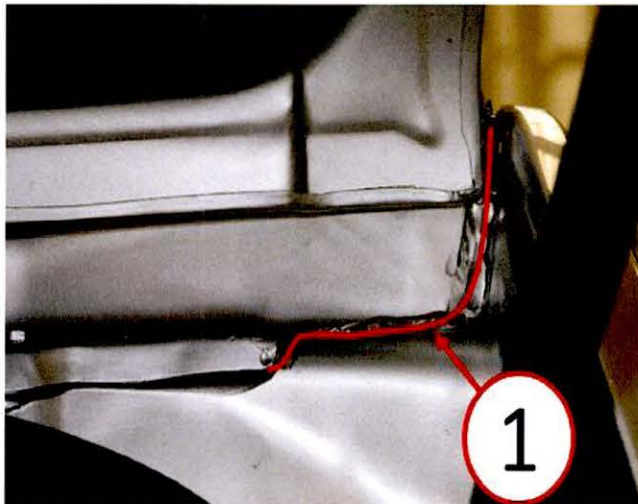
Fig. 4 Sealer Applied - Right Side Shown

1 - Sealer Application

5. Apply clear seam sealer to the right and/or left side at the designated areas in (Fig. 4).

NOTE: Ensure sealer is applied so it overlaps into the upper roof ditch seam as well.

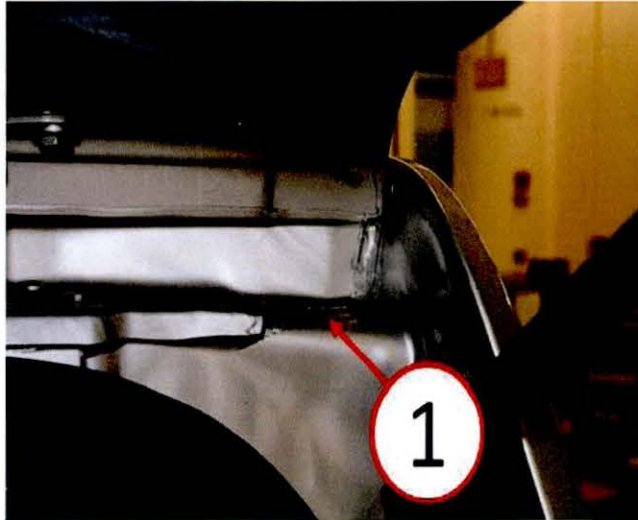
Fig. 5 Brushed Seam Sealer - Right Side Shown

1 - Brushed Seam Sealer

- 6. Once the sealer has been applied use an acid brush to disperse the sealer bead and assure it filled any voids in the seam.
