NUMBER: 23-008-13

Left And/Or Right Door High Closing Effort

2010- 2011	(KA)	Nitro
2010- 2012	(KK)	Liberty

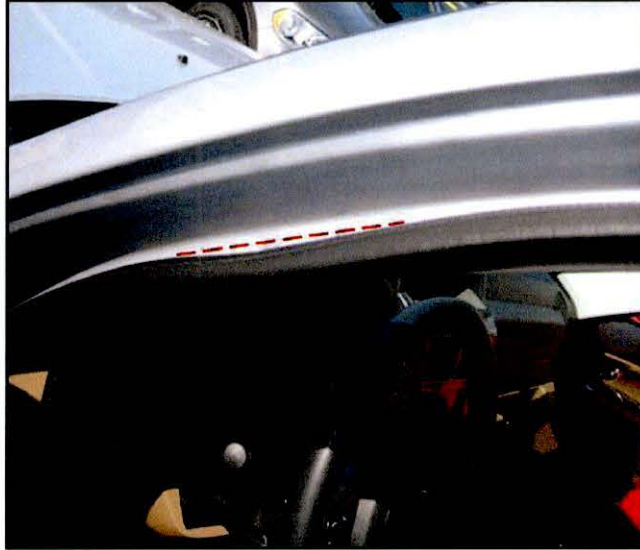
Fig. 1 Inspect Seal Placement

NOTE: Seal should be fully seated all around the door perimeter.

1. Open the door and check the body mounted seal for proper installation and correct as necessary (Fig. 1).

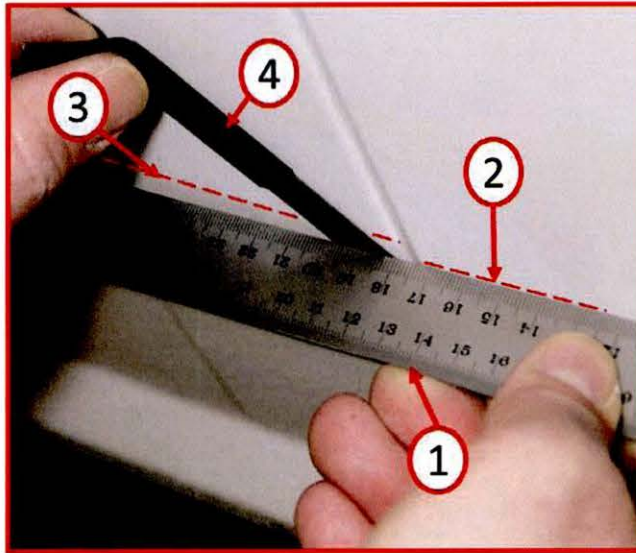
Fig. 3 Measure Overflush

NOTE: Maximum overflush should not exceed 1 to 1.5mm (.039"-.059").

5. Using a feeler gage or equivalent, carefully determine the amount of front door overflush (Fig. 3).
