**NUMBER:** 23-015-13

Ram Box Lid Discoloration (X50 Warranty Extension)

2010 (DS) Ram 1500 Pickup

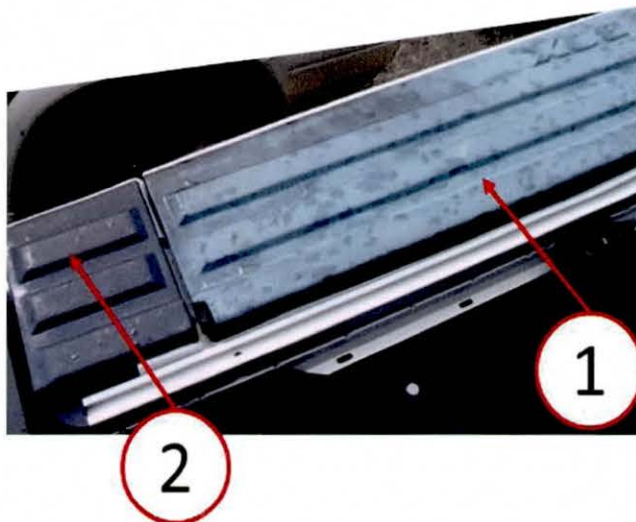
**Fig. 1 Ram Box**

1. Inspect the right and left black texture top surface on the Ram Box Lid. Is the surface fading or does it appear chalky or green ([Fig. 1](#))?
  - a. Yes >>> Replace the suspect Ram Box Lid assembly. Refer to the detailed service information in DealerCONNECT> TechCONNECT> Service Information tab> 23-Body> Box, Pickup> Removal/Installation> RAM BOX STORAGE.
  - b. No >>> Return the vehicle to the customer.
