NUMBER: 23-017-13 REV. A

DATE: May 21, 2013

Rattle And/Or Buzz At The Right Rear Of Vehicle And/Or Fuel Door Difficult To Open

2013 (PF) Dart

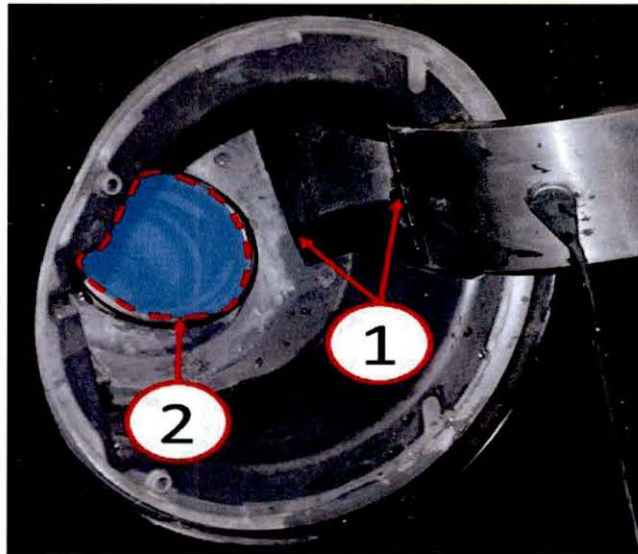
Fig. 1 Fuel Filler Hinge Pocket

- 1 - Hinge Pocket Corner Holes
 2 - Protect Fuel Filler Neck

1. Is this vehicle in the Canadian Markets or in cold states which include Alaska, Colorado, Idaho, Maine, Michigan, Minnesota, Montana, New Hampshire, New York, North Dakota, South Dakota, Utah, Vermont, Wisconsin and Wyoming?
 - a. Yes >>> Proceed to [Step #2](#).
 - b. No >>> Proceed to [Step #6](#).
2. Open the fuel filler door and remove the fuel cap.
3. Cover the fuel filler neck with a rag or masking tape to prevent debris from entering the area.
4. Drill two 6mm (1/4") holes at the hinge pocket corner locations shown in ([Fig. 1](#)).

NOTE: : The housing and hinge pocket has a thickness of 3mm (1/8in), so a drill stop should be used at 5mm (3/16in) to ensure that nothing behind the housing is damaged from the drill bit.

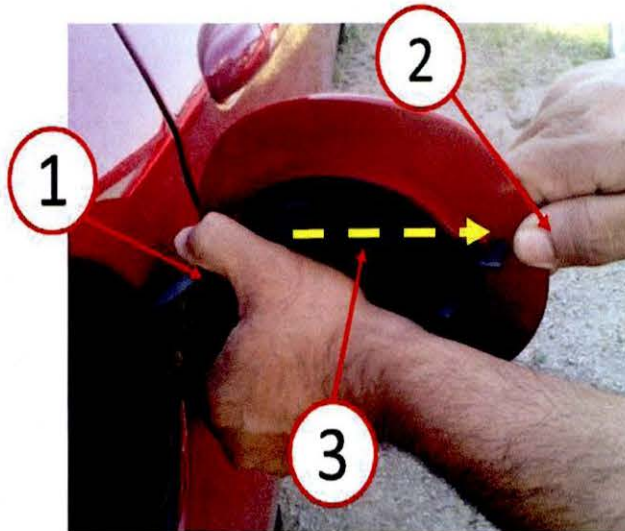
Fig. 2 Fuel Filler Door Inspection

- 1 - Door Hinge
- 2 - Grasp the Fuel Door Here
- 3 - Pull Direction

6. Does this vehicle exhibit a rattle and/or buzz at the right rear of vehicle and/or is built on or after May 03, 2012 (MDH0503XX) and on or before October 08, 2012 (MDH1008XX)?
 - a. Yes >>> Proceed to **Step #7**.
 - b. No >>> Proceed to **Step #12**.
7. Inspect the fuel fill door and verify it is fully seated. With the fuel door open perform a light push pull around the fuel fill door. Grasp the fuel fill door hinge (1) with one hand and position the other at the rear edge of the door (2) lightly pulling out board (3) at the locations shown in (Fig. 2).

-
8. Did the fuel door cover separate from the fuel door housing?
 - a. Yes >>> Proceed to **Step #9**.
 - b. No >>> Proceed to **Step #12**.
 9. Remove and reinstall the fuel fill door. Refer to the detailed service procedures available in: DealerConnect> TechCONNECT under: Service Info> 23-Body> Exterior> DOOR, Fuel Fill> Removal/Installation. Did the fuel fill door fully seat when reinstalled?

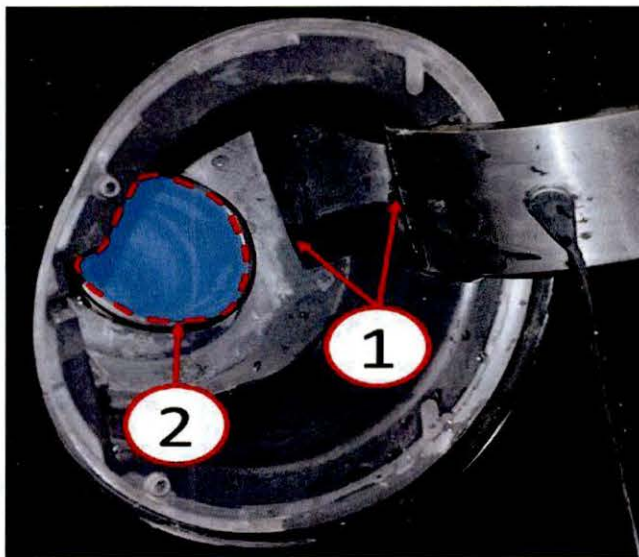
Fig. 3 Fuel Filler Hinge Pocket

- 1 - Hinge Pocket Corner Holes
2 - Protect Fuel Filler Neck

12. Is the vehicle located in a market other than Canada or cold states which include Alaska, Colorado, Idaho, Maine, Michigan, Minnesota, Montana, New Hampshire, New York, North Dakota, South Dakota, Utah, Vermont, Wisconsin and Wyoming?
 - a. Yes>>> Proceed to **Step #13**.
 - b. No>>> Return the vehicle to the customer or dealer inventory.
13. Open the fuel filler door and remove the fuel cap.
14. Cover the fuel filler neck with a rag or masking tape to prevent debris from entering the area.
15. Drill two 6mm (1/4") holes at the hinge pocket corner locations shown in (Fig. 3).

NOTE: The housing and hinge pocket has a thickness of 3mm (1/8in), so a drill stop should be used at 5mm (3/16in) to ensure that nothing behind the housing is damaged from the drill bit.
