Technical Service Bulletin

34 - 6th gear jumps out - 0B1/0B2 gearbox

34 13 15 2026719/4 February 14, 2013. Supersedes Technical Service Bulletin Group 34 number 13-14 dated January 30, 2013 for reasons listed below.

Model(s)	Year	VIN Range	Vehicle-Specific Equipment
A4	2010-11	All	2.0L with manual transmission
A5	2010-11	All	2.0L with manual transmission

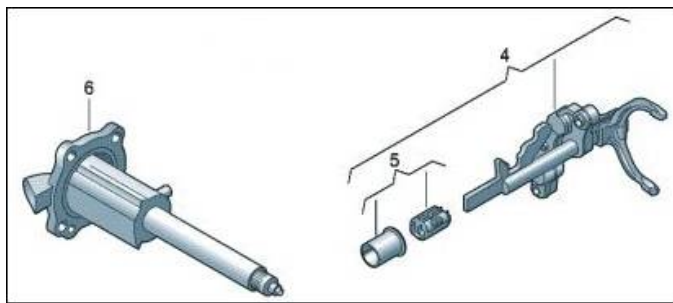
Figure 1. Shift fork and gear shift unit

The transmission jumps out of 6th gear.

Improved 5th and 6th shift fork and gearshift unit.

4. Replace the 5th - 6th gear shift fork and ball sleeve (*Item 4 and 5, Figure 1*) and the gear shift unit (*Item 6 Figure 1*) per instructions in *ELSA: Transmission*>> *Manual Transmission Internal Components*>> *34 Controls, Housing*>> *Disassembly and Assembly*>> *Transmission, Assembly Sequence* **AND** *35 Gears, Shafts*>> *Disassembly and Assembly*>> *Shift Fork Group, input shaft*.

Tip: When replacing the shift fork and ball sleeve, no further disassembly of input shaft is required.
