# Service Bulletin

Bulletin No.: PIC5933

**Subject:** Rear Fascia Not Flush To Rear Quarter Panel

**Models:** 2013 - 2014 Chevrolet Malibu

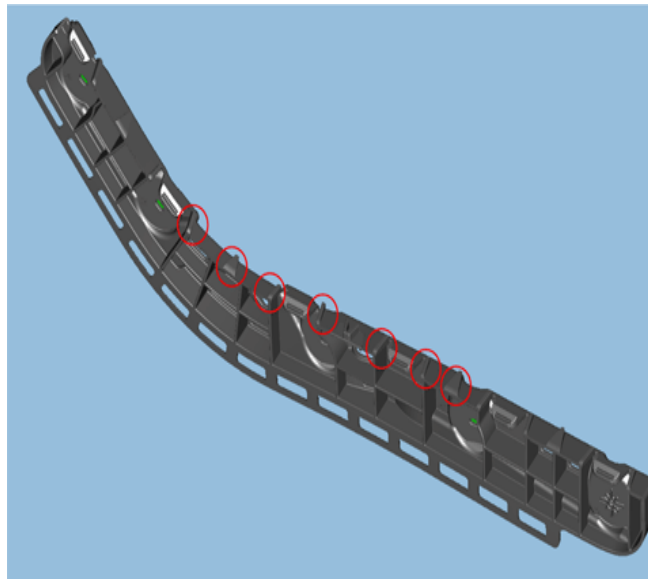
3649283

A customer may indicate the rear fascia does not fit flush with rear quarter panel on either side of the vehicle. Build tolerance may cause a condition in which the distance between the rear fascia bracket and the quarter panel is too tight. This may not allow the rear bumper fascia to seat into the bracket.

Using the image below as a guide, remove the seven (7) indicated standoffs from the Rear Bumper Fascia Outer Guide on the effected side. Once the standoffs have been removed, reinstall the fascia and confirm proper fit.
