Service Bulletin

Bulletin No.: PIC5894

Subject: Multiple IPC Warning Indicators DIC Messages Displayed And Or Loss Of Communication DTCs In Various Modules

Models: 2014 Chevrolet Impala

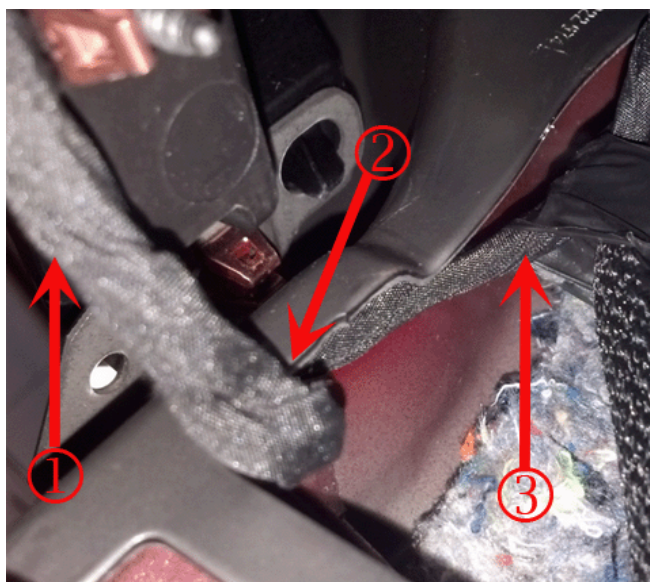
3582171

These conditions can be caused by a pinched DLC branch in the IP Harness behind the IP Carrier.

1. To DLC
2. Location of Pinch
3. To BCM

If the DLC branch is found to be pinched it will be necessary loosen the Left Lower IP Carrier Bolt to free-up the harness and repair the wiring. Refer to Service Information for wiring repair information.

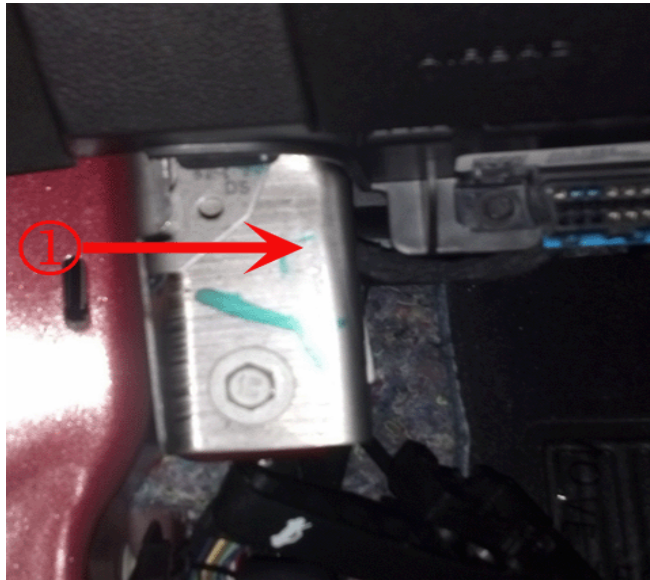
3582174

1) Location of Pinched DLC branch directly behind IP Carrier
