# Service Bulletin

Bulletin No.: PIC5886

**Subject:** Hood To Fascia Adjustment Procedure

**Models:** 2012 - 2013 Chevrolet Camaro ZL1

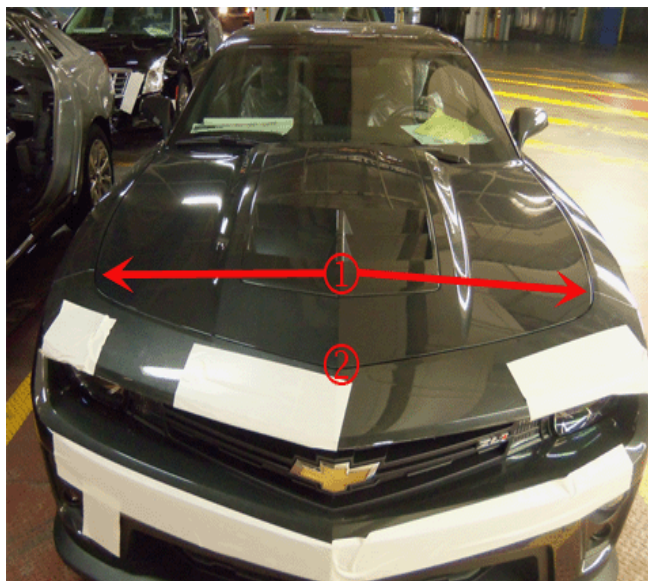
3530644

There may be a fit concern of the hood-to-front fascia being too high or too low to each other.

Use the following inspections and adjustments, as applicable, to improve the hood to front fascia fit / appearance. Only perform the adjustments necessary to achieve the appropriate specs listed below.
