Service Bulletin

Bulletin No.: PIC5884

Subject: Trunk Lid Does Not Self Raise Completely

Models: 2014 Chevrolet Impala (New Body Style)

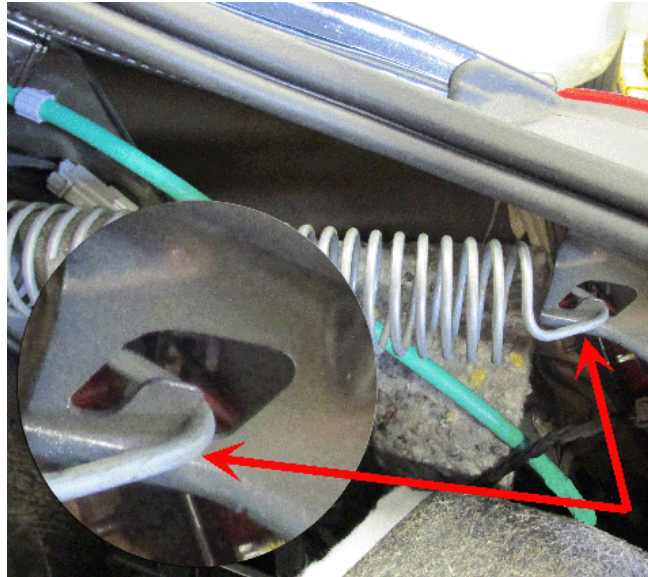
3530798

It may be noticed that the Trunk lid does not self-raise to the full upright position when released. This applies only to vehicles with Factory-Installed Rear Spoilers or Dealer-Installed GM Accessory Rear Spoilers.

Loosen and reposition the trunk trim to gain access to the trunk lift springs. Assure that both trunk lift springs are in the rear-most position as shown below:
