# Service Bulletin

Bulletin No.: PIC5861

**Subject:** SES MIL DTC P0442

**Models:** 2010 - 2012 Buick LaCrosse  
Equipped with 3.0L (RPO LF1) or 3.6L (RPO LLT)

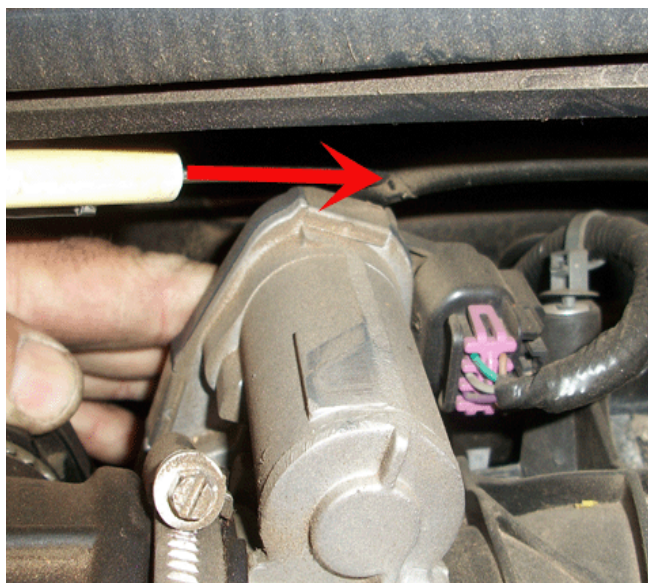
3436210

Visually inspect evaporative pipe for contact with the throttle body. If contact is present, replace the evaporative pipe as needed and secure to eliminate future contact. Clear DTCs.

**Note:** The new evaporative pipe will have a conduit installed in the area of concern of the original pipe. Reference photos below.
