TECHNICAL BULLETIN  
JTB00293NAS1  
26 APR 2013

Incorrectly Wired Auxiliary Input Jack

**XJ Range (X351)**

**VIN: V39427-V48016**

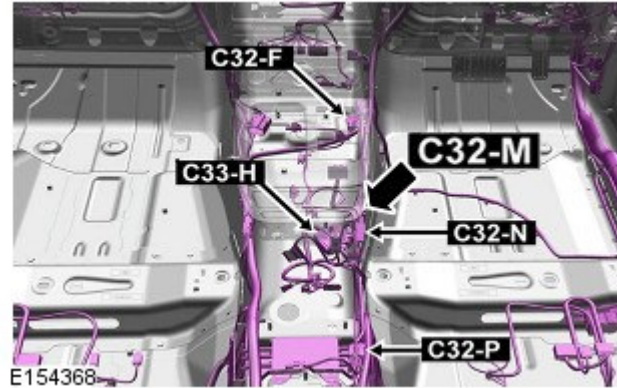
Access connector C32-M (connection between user interface panel and Aux).

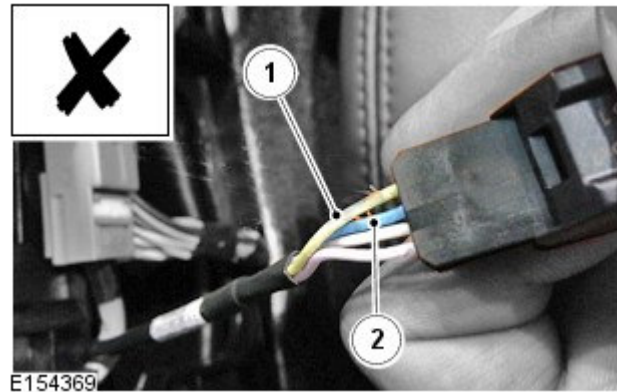
**Cause:** This may be caused by an incorrectly wired connector C32-M.

**NOTE: In-vehicle condition – INCORRECT (Blue (BU) in cavity 3; Yellow (YE) in cavity 4).**

Using suitable pin out tool, change the pin location of the Blue (BU) and Yellow (YE) wires:

1. Yellow wire (YE) to cavity 3.
2. Blue wire (BU) to cavity 4.

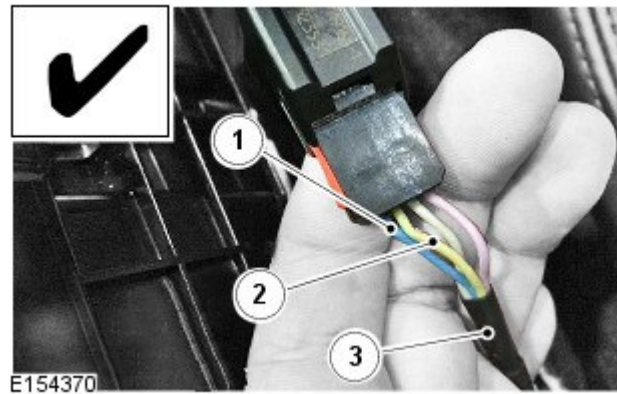
4. Harness with wires in the correct condition.

1. Blue wire (BU) in cavity 4.
2. Yellow wire (YE) in cavity 3.
3. Connector C32-M harness.
