TECHNICAL BULLETIN
JTB00294NAS1
31 MAY 2013

Window Regulator Noise During Operation

XF (X250)

Model Year: 2012-2013

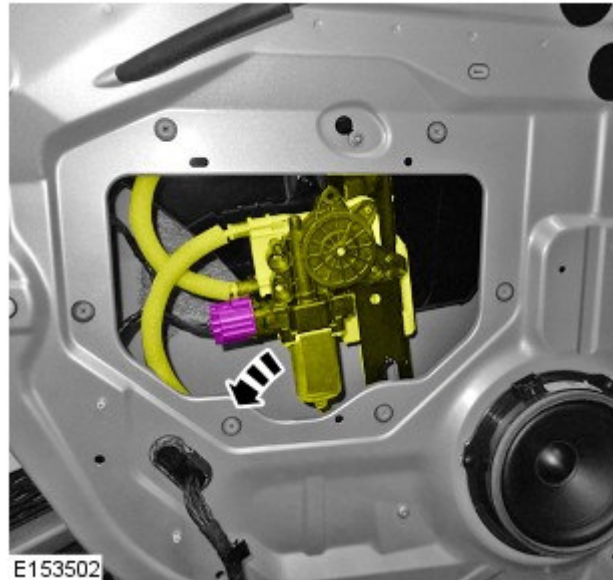
**NOTE: Rear left door shown; other doors similar.**

Remove the affected window regulator (see TOPIX Workshop Manual section 501-11: Window Regulator and Motor).

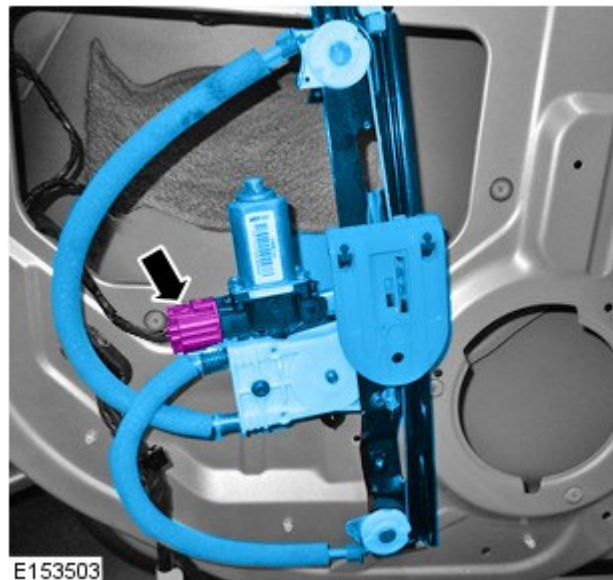
**NOTE: Rear left door shown; other doors similar.**

**NOTE: Cover the top of the regulator to stop it damaging the door.**

Turn the regulator around and secure it to the bottom key way.
