TECHNICAL BULLETIN JTB00297NAS1 06 SEP 2013

SECTION: 204-04

Tire Pressure Monitoring System - Improved Diagnostics and Service Information

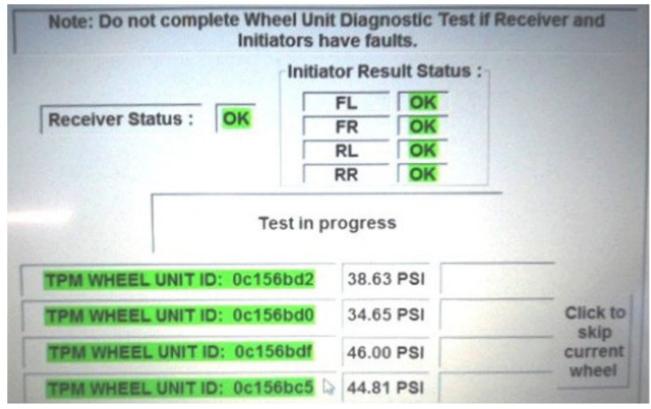
E160357

New Symptom and DTC mapping is available with the revised diagnostics introduced on IDS-DVD133.04 v.130. Additionally, a new diagnostic function - Tire Pressure Monitoring Wheel Sensor Test - which should be used when required and directed by the help text from the SDD tool or TOPIx, has been released to lessen the time necessary to diagnose a wheel/tire assembly requiring attention. System Fault Warnings can no longer be present without the

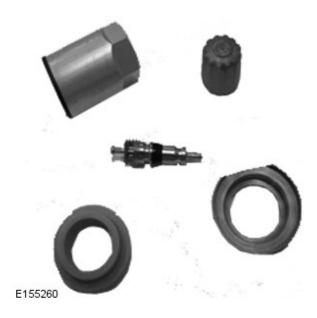
7. NOTE: To service XJ (X351 V00047-V21615) original-fit sensor with serviceable valve stem only; sensor no longer available

TG1C Service kit - hardware and seals **only**; no valve stem

• Part number C2D29156; currently fits:

• XJ (X351, V00047-V21615 original-fit sensor with serviceable valve stem only)

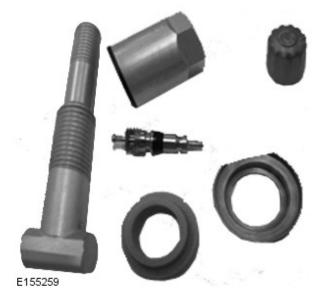
8. NOTE: To service XJ (X351 V00047-V21615) original-fit sensor with serviceable valve stem only; sensor no longer available

TG1C Service kit - hardware, seals, and valve stem

- Part number C2D29157; currently fits:
 - XJ (X351, V00047-V21615 original-fit sensor with serviceable valve stem only)
