TECHNICAL BULLETIN

UPS2613-1bNAS1

Update Prior to Sale: Charge Air Cooler Clip / Hose Inspection

XF (X250) 2.0L GTDi engine only

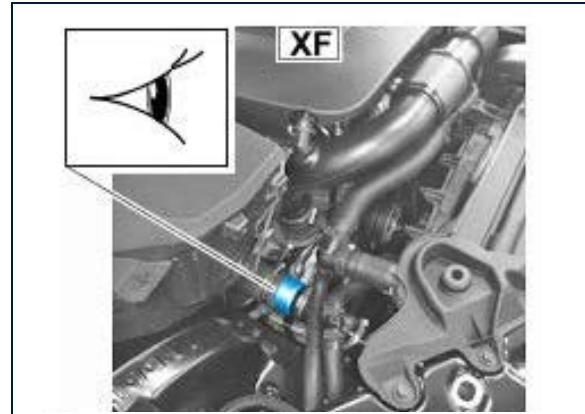
1. Open the vehicle hood.
2. Locate the Charge Air Cooler hose-to-resonator connection.

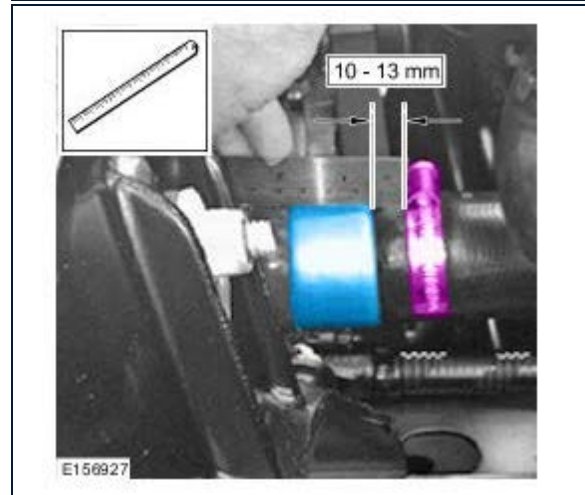
3. Check the position of the Charge Air Cooler hose clip:
 - If the clip is between 10mm and 13mm from the edge of the resonator and the hose is butted against the resonator, continue to step 6.
 - If the clip is less than 10mm from the resonator, a gap exists between the resonator and the end of the hose, or the clip is not positioned squarely on the hose, continue to step 4.

4. For any clips or hose found to be in the incorrect position, raise an EPQR, attach a photograph of the clip or hose with a ruler next to it so that the out of position measurement can be estimated from the photograph, and submit the EPQR with a reference in the description to this UPS.
5. Reposition hose correctly on the resonator and position the clip 13mm from the edge of the resonator.
6. Tighten the clip to 6Nm, ensuring the clip remains in position and square to the edge of the resonator.
7. Close the vehicle hood.
