TECHNICAL BULLETIN  
JTB00191NAS3  
06 SEP 2013

**SECTION: 501-12**

Glove Compartment Lid Not Damped When Opening

**XK Range (X150)**

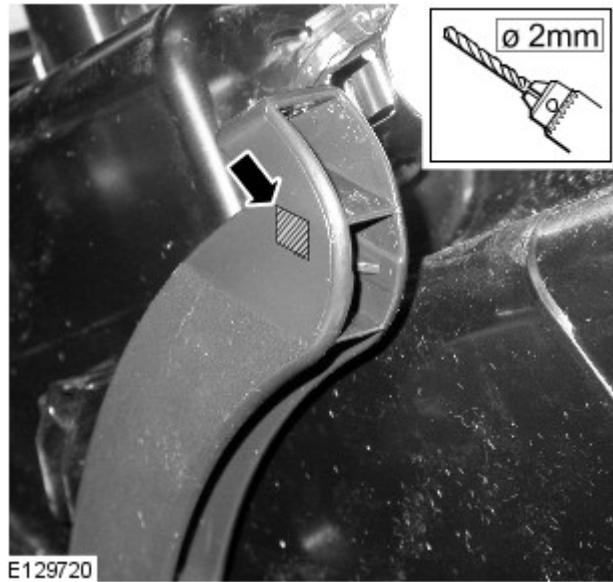
**Situation:** The glove compartment lid may not be damped when opening.

**Cause:** This may be caused by the glove compartment lid damper cord retaining tab coming away from the glove compartment housing.

1. Remove the glove compartment (see TOPIx Workshop Manual, Section 501-12).
2. Using a suitable 2mm drill, drill a hole (shown in the shaded area) through the glove compartment damper arm.
