NUMBER: 23-024-13

DATE: July 11, 2013

Rattle, Ticking, Or Creak At Console/Shifter Area

2013 (JK) Wrangler

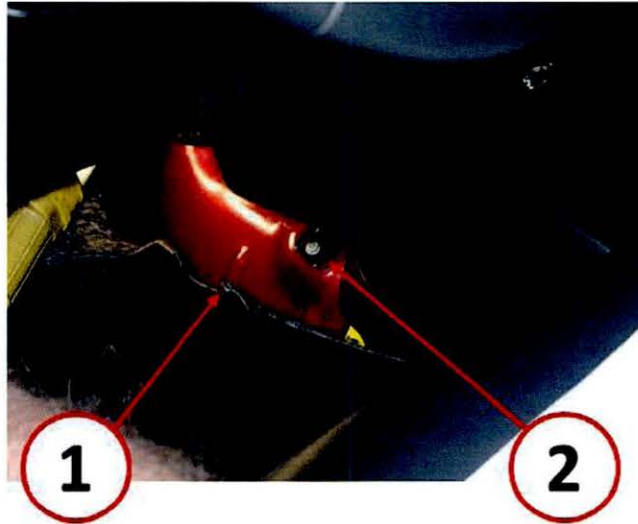
Fig. 1 Remove Carpet

1. Test drive vehicle to identify customer complaint matches bulletin symptom/condition.
2. Pull back floor tunnel carpet (1) near lower instrument panel on left side to expose instrument panel support bracket (2) (Fig. 1).

- 1 - Floor Tunnel Carpet
 - 2 - Instrument Panel Bracket
-

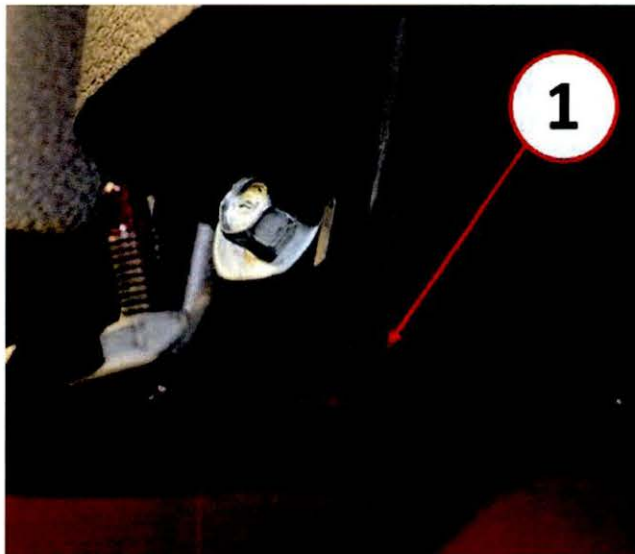
Fig. 2 Bracket Touching

3. Inspect for contact between instrument panel magnesium bracket and floor pan (Fig. 2).

- 1 - Bracket to Floor Pan Contact
-

4. If instrument panel magnesium bracket appears to be contacting floor pan, than proceed with repair. If instrument panel magnesium bracket was found to be tight, secure, and not contacting floor pan, than reinstall carpet and continue with further diagnosis.

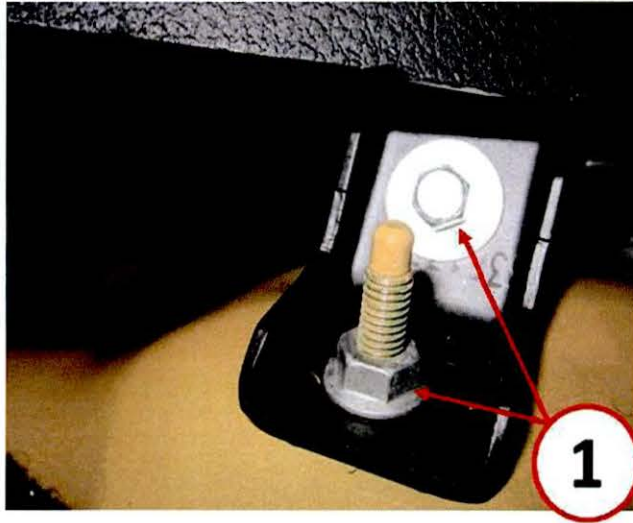
Fig. 3 Loosen Fasteners

1 - Instrument Panel Fasteners

1. Loosen both instrument panel bracket fasteners to allow for movement of the instrument panel magnesium bracket (Fig. 3).

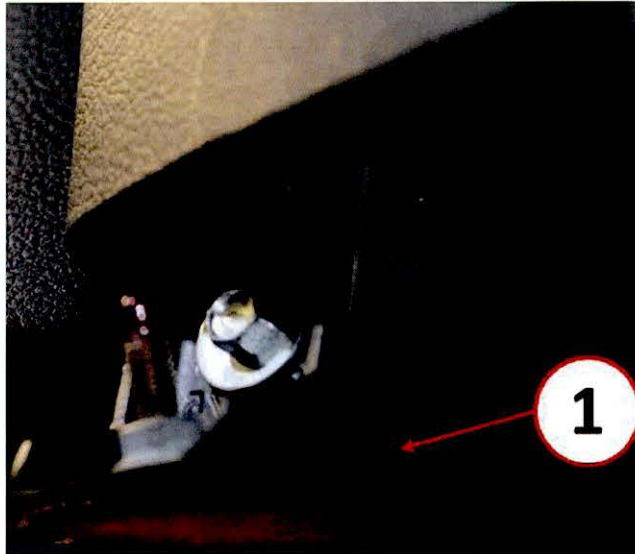
Fig. 4 Adjust Height

1 - Bracket to Floor Pan Clearance

2. Pry up on instrument panel magnesium bracket to ensure clearance between the magnesium bracket and floor pan (Fig. 4).

NOTE: A minimum of 2-3mm of clearance is needed between bracket and floor pan.

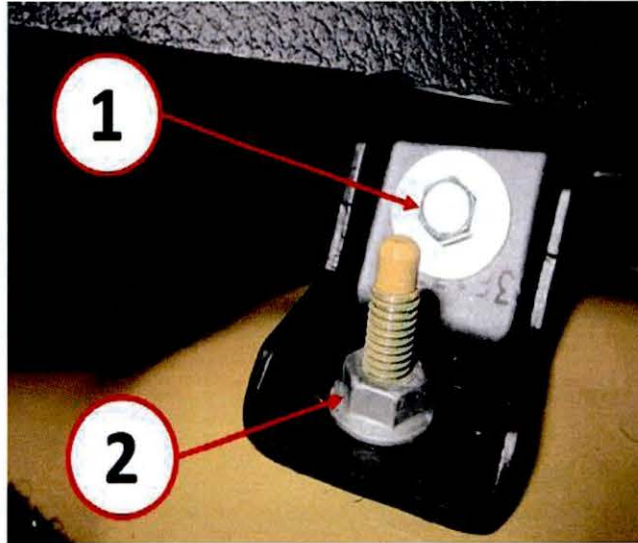
Fig. 5 Tighten Fasteners

- 1 - Magnesium Bracket Bolt
- 2 - Floor Pan Nut

3. Tighten bolt (1) to magnesium bracket to 14 +/- 2 N-m and tighten nut (2) to floor pan to 8 +/- 2N-m (Fig. 5).

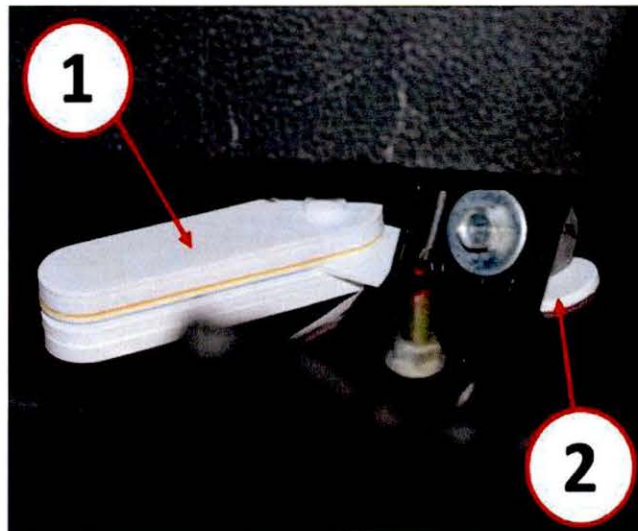
Fig. 6 Check Distance

- 1 - Feeler Gauge
- 2 - Clearance Measurement

-
4. Using feeler gauge (1) and/or equivalent, verify that clearance (2) of 2-3mm between the magnesium bracket and the floor pan has been maintained (Fig. 6).
