NUMBER: 23-025-13

Buzz Noise While Playing Base Audio

2013	(JS)	Chrysler 200
2013	(JS)	Lancia Flavia

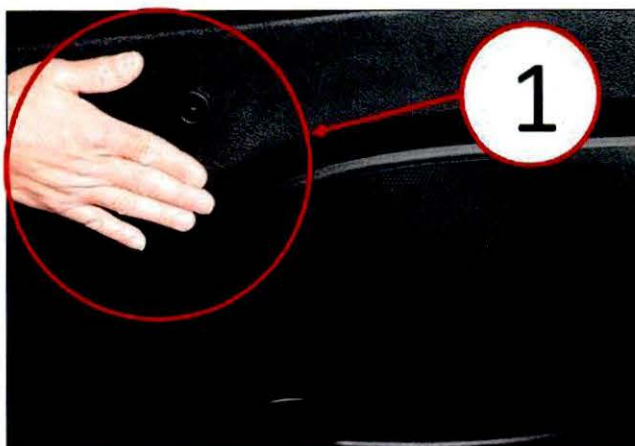
Fig. 1 Verify Noise

2. Press with hand on the forward, upper corner of the right rear quarter trim panel to cancel the buzzing noise (Fig. 1).

1 - Cancel Buzzing Noise

3. If buzzing noise is canceled by pressing on quarter trim panel, than proceed with repair. If buzzing noise is not affected by pressing on quarter trim panel, than further diagnosis is required.

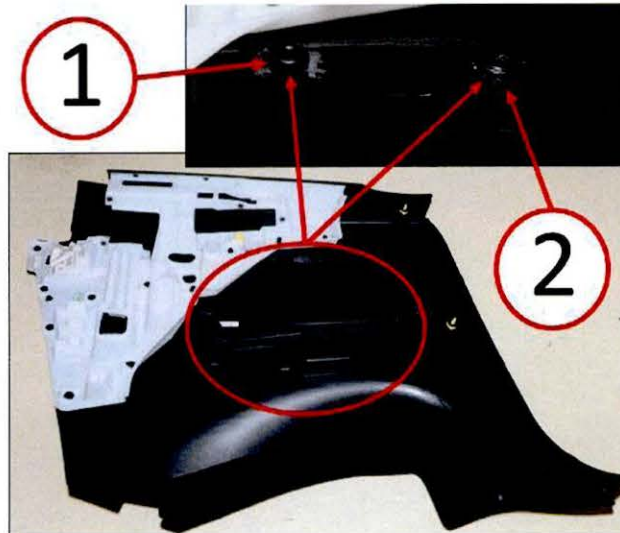
Fig. 2 Inspect Welds

1. Remove the right rear quarter trim panel. Refer to the detailed repair procedures available in: DealerConnect> TechCONNECT under: 23 - Body> Interior> PANEL, Quarter Trim> Removal> CONVERTIBLE.
2. Inspect the sonic welds attaching the speaker grill to the quarter panel. Welds that are tight and secure (2) are acceptable. If any welds are found to be loose (1) they will cause buzzing noise and will require quarter panel replacement (Fig. 2).

- 1 - Bad Weld
- 2 - Good Weld

3. Install the right rear quarter trim panel. Refer to the detailed repair procedures available in: DealerConnect> TechCONNECT under: 23 - Body> Interior> PANEL, Quarter Trim> Installation> CONVERTIBLE.
4. Verify that repair was successful by playing audio with heavy bass tones through the right rear speaker.
