**NUMBER:** 23-026-13 REV. A

Window Travel Calibration Malfunction

2013 (ZD) Viper

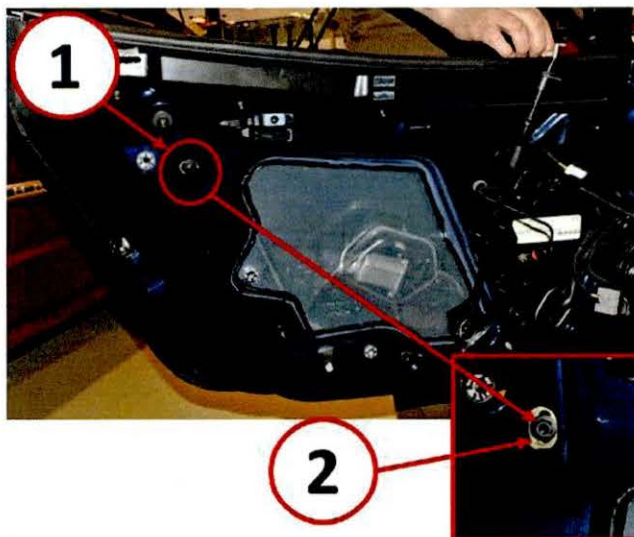
**Fig. 1 Window Up Stop Adjustment**

The door glass regulator up-stop that prevents the glass from over-travel is not adjusted correctly. If an over-travel situation occurs, such as the glass missing the seal channel, a new, closed position will be learned. This condition will result in auto reversals (anti-pinch) and eventually loss of calibration (several consecutive reversals).

1. This procedure is to be performed on both right and left door windows at same time even if only one is found to malfunction.
2. Lower the door window glass on both doors half way to allow for up-stop limit adjustment.
3. Remove the door panel on both doors. Refer to the detailed repair procedures available in: DealerConnect> TechCONNECT under: Service Info> 23 - Body> Door - Front> PANEL, Door Trim> Removal.
4. Loosen the window up-stop limit adjustment bolt (1) and tap area lightly to ensure up-stop limit bracket (2) drops down to bottom of slotted hole. (Fig. 1).

7. Using WiTech, raise the windows fully.
8. Tighten the up-stop limit adjustment bolt (1) to 7 +/- 2N-m.(Fig. 1).
9. Open the doors.
10. Install the door panel on both doors. Refer to the detailed repair procedures available in: DealerConnect> TechCONNECT under: Service Info> 23 - Body> Door - Front> PANEL, Door Trim> Installation.
